**PROJECT CAPITAL NEEDS ASSESSMENT
SECTION 232/223(f)
POLK CITY NURSING AND REHABILITATION
1002 WEST WASHINGTON AVENUE
POLK CITY, IOWA 50226
PROJECT NO. 103P067025**

Report Date: November 22, 2019
On-Site Date: November 12, 2019

Tetra Tech, Inc.
712 Melrose Avenue
Nashville, Tennessee 37211
Telephone (615) 252-4788

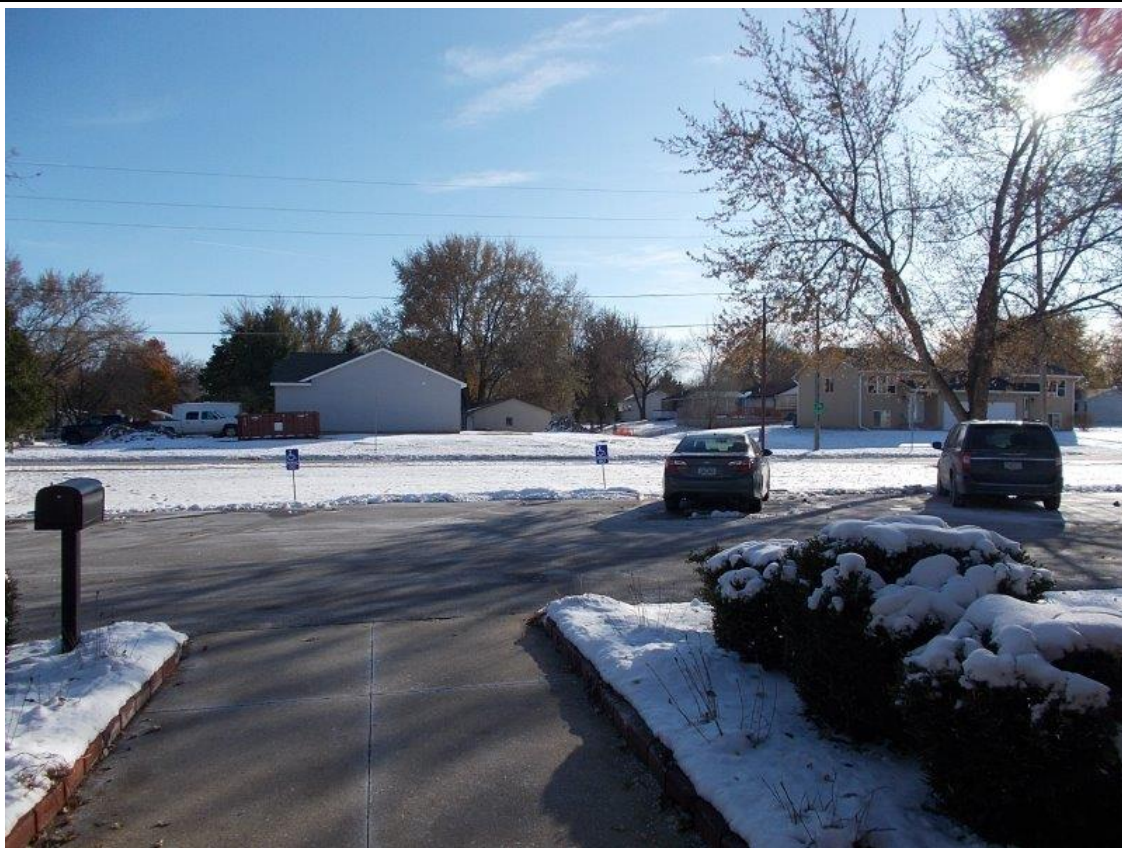
Description:	View of two standard handicapped parking spaces in the southern lot near the main entrance, facing south.
---------------------	---

Recommendation (Critical Repair): Combine one standard parking space and one standard handicapped space in the south visitors lot to create a striped access aisle and install signage compliant with UFAC requirements. Estimated cost \$675.

Recommendation (Critical Repair): Install a van accessible handicapped sign in the handicapped space with the 96 inch wide access aisle in the south visitors parking lot. Estimated cost \$750.

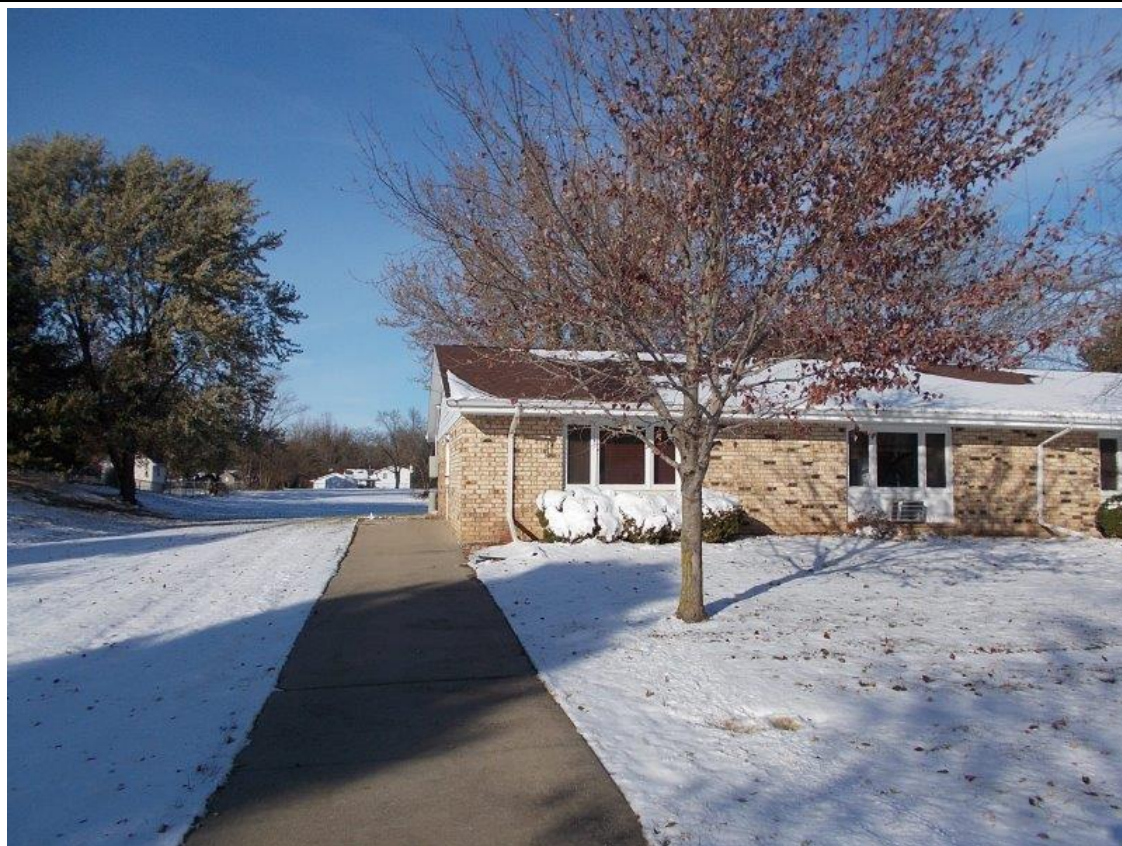
Description:	View of a raised sidewalk slab on the western sidewalk, facing north.
---------------------	---

Recommendation (Critical Repair): Replace two sections of damaged and raised sidewalks (damaged concrete slabs on the east side of the building and concrete sidewalk at the end of the north wing with raised slabs). Estimated cost \$5,000.

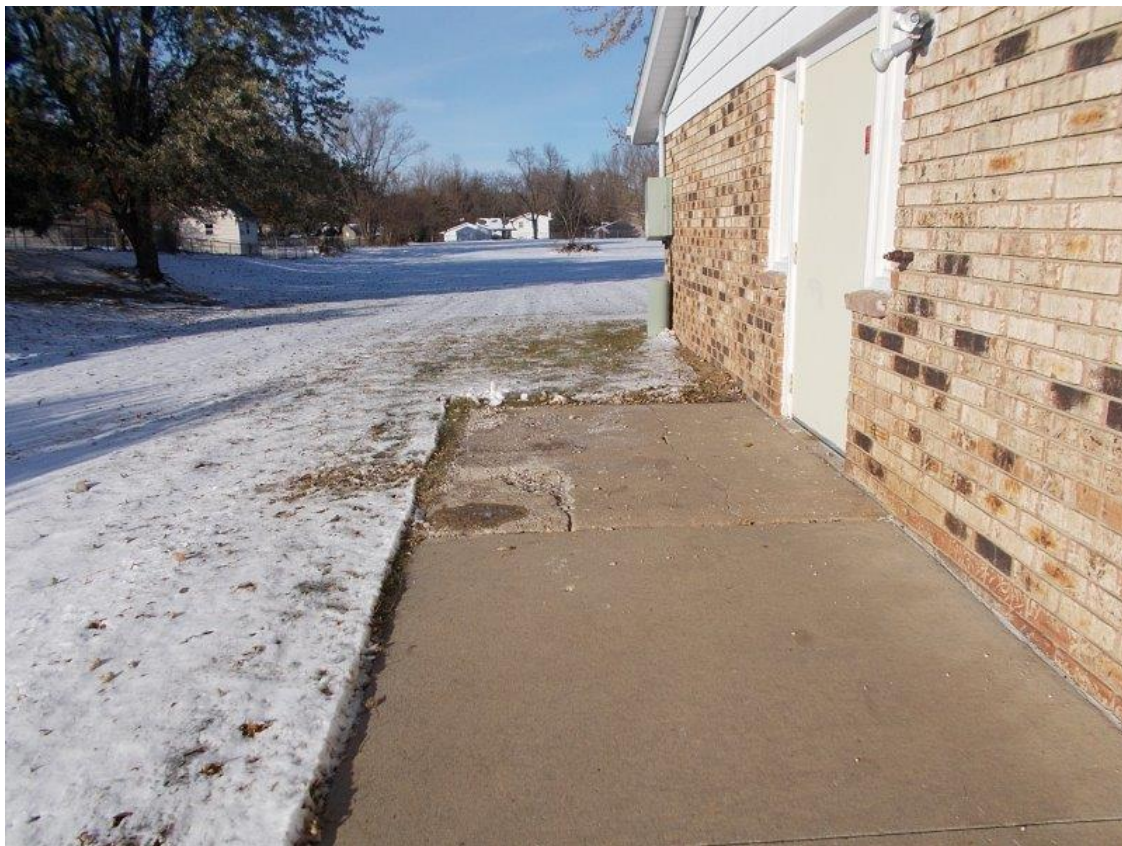
Description:	View of a damaged concrete sidewalk slab by the western end of the building, facing north.
---------------------	--

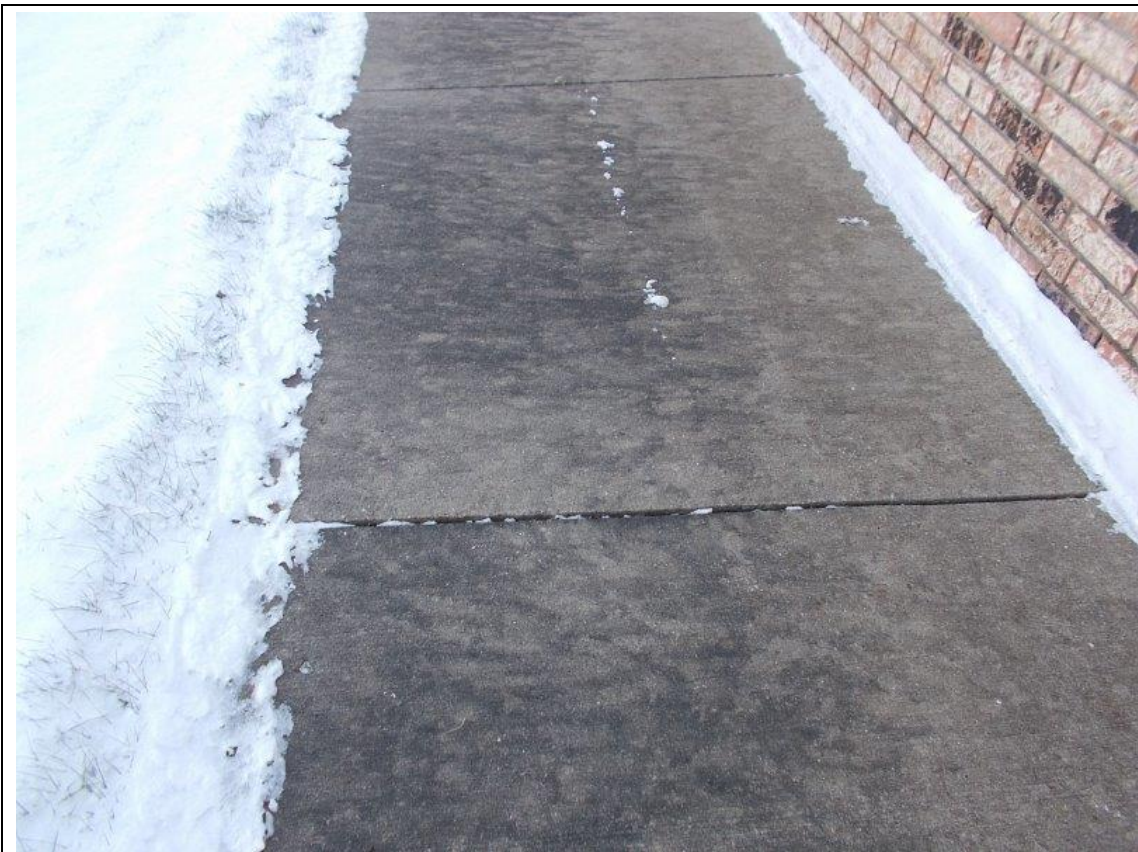
Description:	View of raised sidewalk slab on the northern end of the building, facing west.
---------------------	--

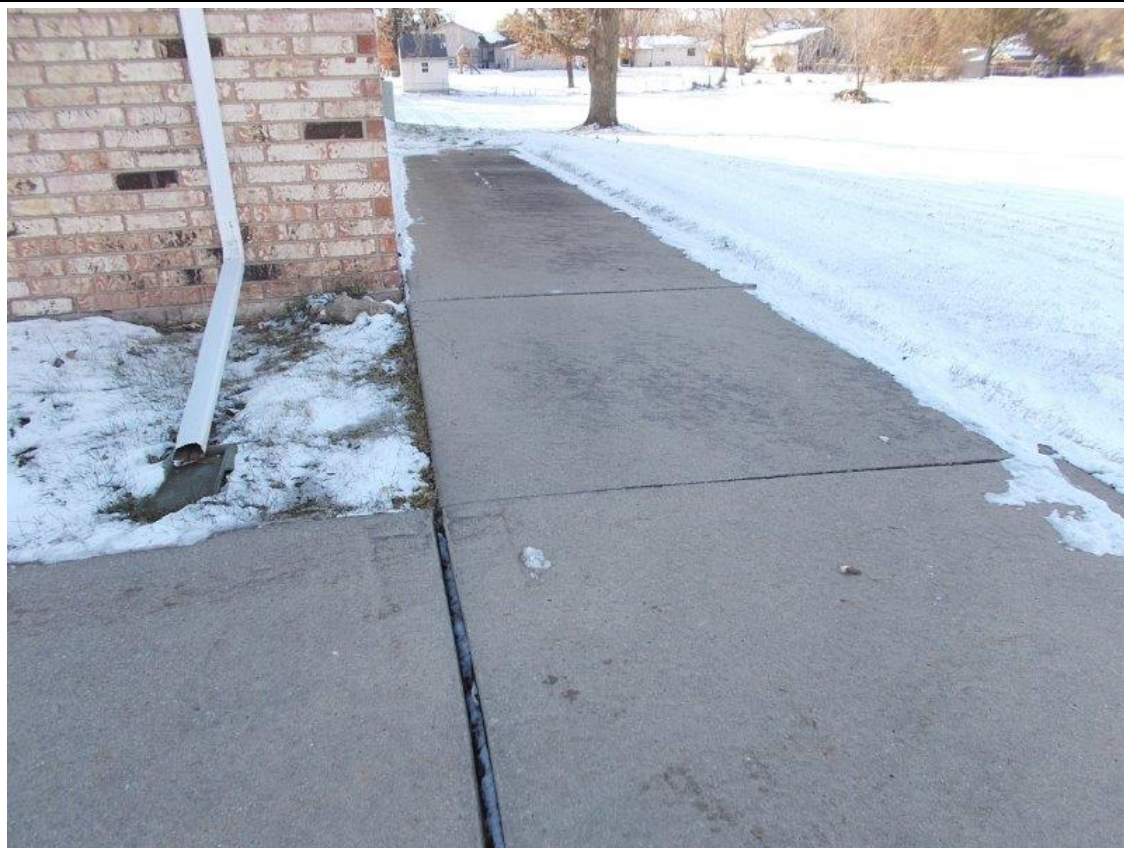
Description:	View of the northern sidewalk, facing east. Most of the slabs are raised or sunken and the entire east-west length presents trip hazards that need to be addressed.
---------------------	---

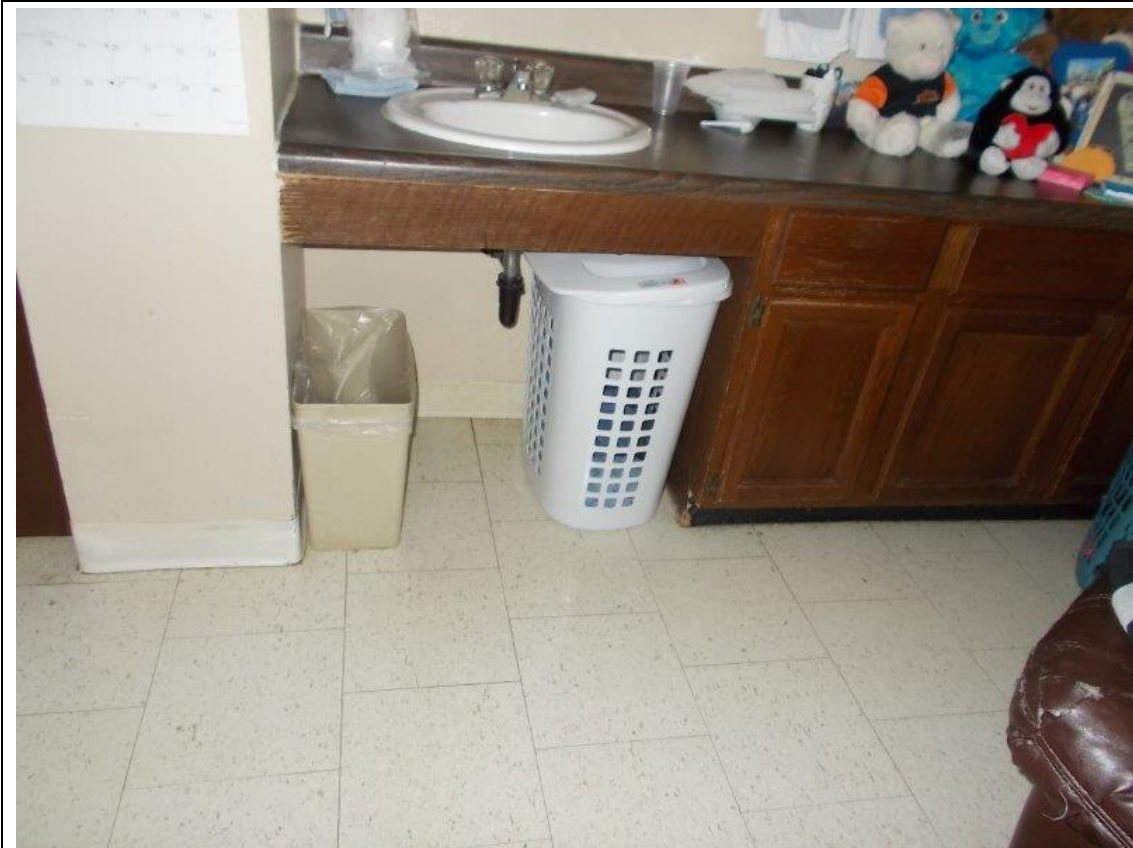
Description:	View of a vanity in a triple occupancy resident room. Note the uninsulated p-trap.
---------------------	--

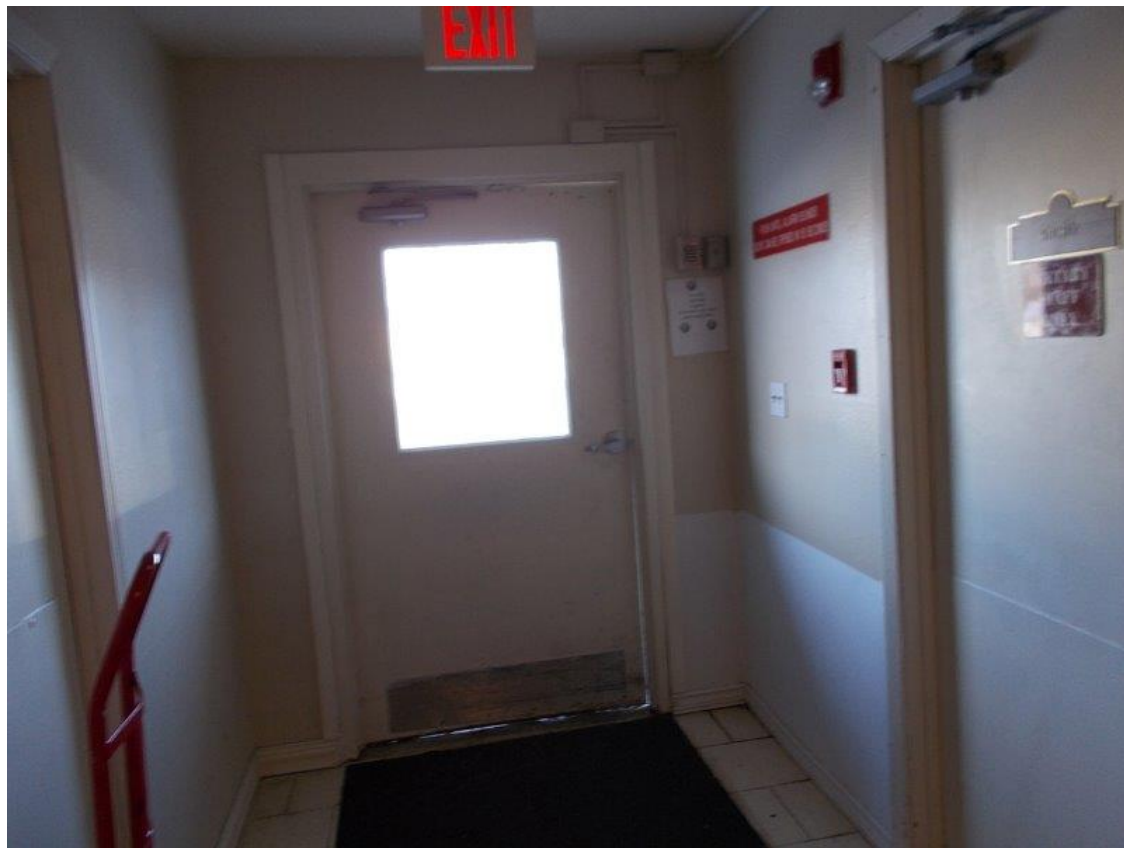
Description:	View of an exterior door in the service hallway. Note the gaps between the door and the frame.
---------------------	--
