ZONING ANALYSIS REPORT

3105 N Wilke Road
Arlington Heights, Cook County, Illinois 60004

AEI Project No. 462597
Client Reference Name: Arlington Pediatric Therapy

PROPERTY CONDITION REPORT - EQUITY

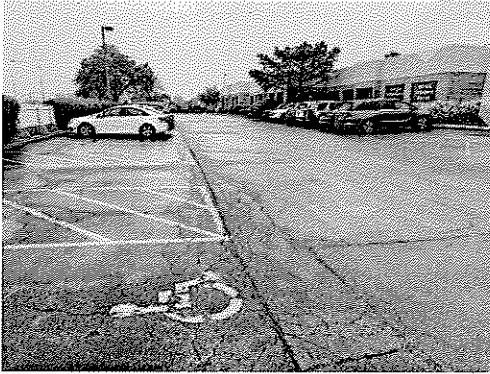
Asphalt parking

AEI recommends periodic crack-filling, seal coating and re-striping of the asphalt paving during the evaluation period. An opinion of cost for the parking leased repairs is included in the Tables.

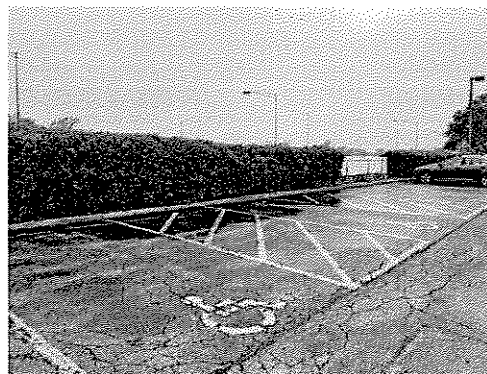
ADA parking without signage

ADA Priorities				
Priority Concerns	Deficiencies Observed	Readily achievable and not a financial burden?	Recommendation	Possible Solution
Parking	Yes	Yes	Repair	Increase the number of accessible ADA Signage
Site Circulation	No	Not applicable	Not applicable	Not applicable
Access to Goods and Services (Interior Circulation)	Not applicable	Not applicable	Not applicable	Not applicable
Public Restrooms or Restrooms shared by multiple Tenants	Not applicable	Not applicable	Not applicable	Not applicable
