AEI Consultants

ZONING ANALYSIS REPORT

3105 N Wilke Road
Arlington Heights, Cook County, Illinois 60004

PROPERTY CONDITION REPORT - EQUITY

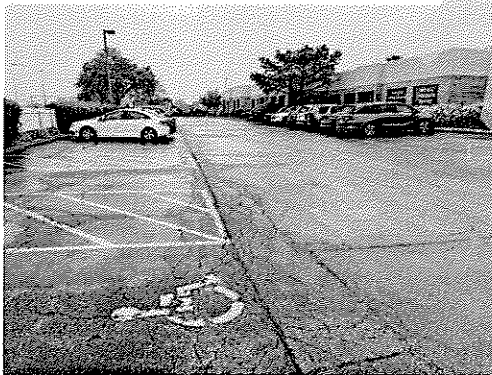
There is onsite asphalt pavement at drive lanes and parking areas. The POC reported that the parking lot is owned and maintained as part of the condominium association. Parking spaces are shared throughout the common condominium association property. Cost of maintenance and repairs to asphalt pavement are collected thru lease agreements.

Asphalt parking

AEI recommends periodic crack-filling, seal coating and re-striping of the asphalt paving during the evaluation period. An opinion of cost for the parking leased repairs is included in the Tables.

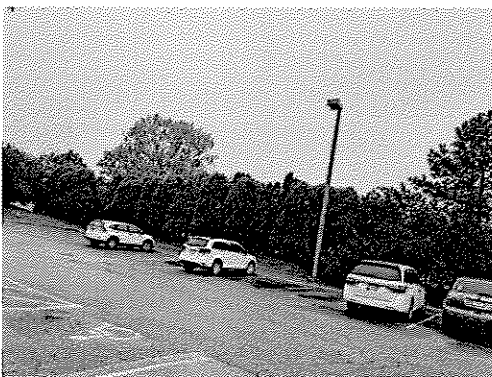
South area parking

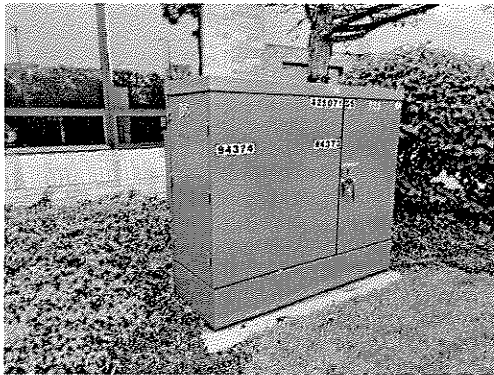
No notable deficiencies or indications of deferred maintenance of utilities were observed or reported. The RULs of these features are expected to exceed the evaluation period.

Pad mounted transformer

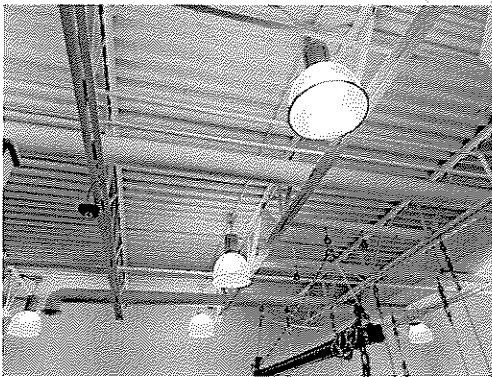
Walls and floors appeared to be plumb, level, and stable. There were no signs of significant deflection or movement. Based on our observations and interviews, the superstructure appeared to be generally appropriate for the architectural style, height, and occupancy of the building, and was judged to be in overall good condition.

Steel frame structure

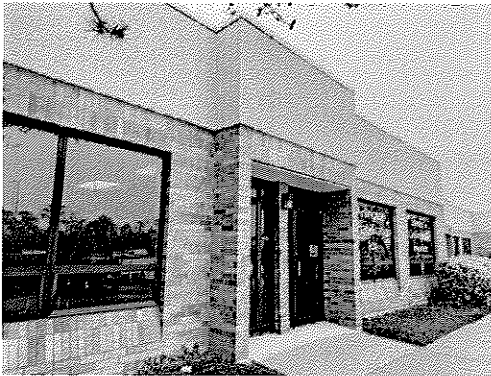
Cladding Descriptions			
Item	Description	Action	Condition
Primary Exterior Wall Finishes and Cladding	Unpainted masonry brick veneer	R&M	Good
Secondary / Accent Exterior Wall Finishes	Exterior insulation finish system (EIFS) along the wall / roof line	ST/RR	Good
Trim Finishes	Metal		
Soffits/Eaves	Not applicable

Front facade entrance

Cost Recommendation	EUL	EFF AGE	RUL	Year	Cost
Exterior walls, Repaint and Recaulk	8	8	0	Short Term 9	\$12,000 \$12,000
Total					\$24,000

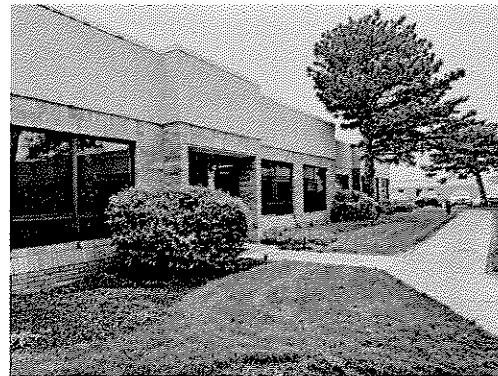
East facade

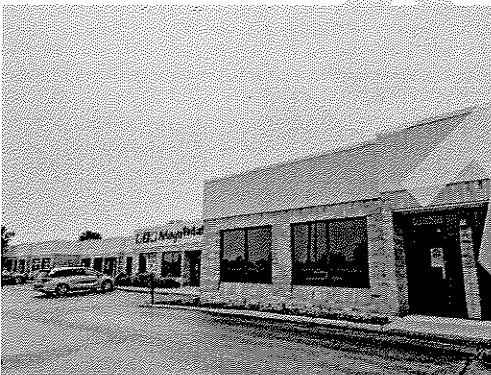
West facing facade

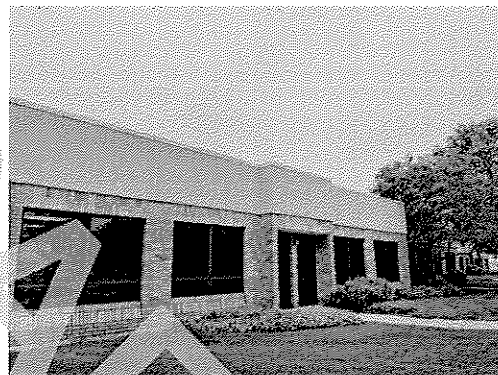
East facing facade

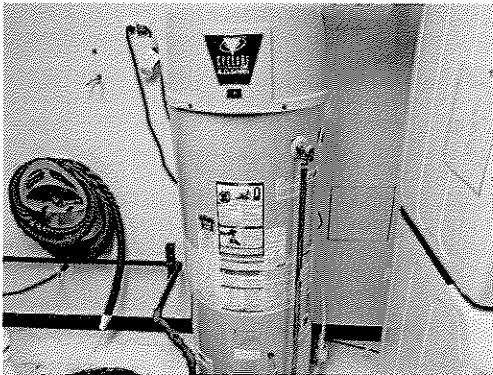
No notable deficiencies or indications of deferred maintenance of distribution piping or water heater systems were observed or reported.

Water heater

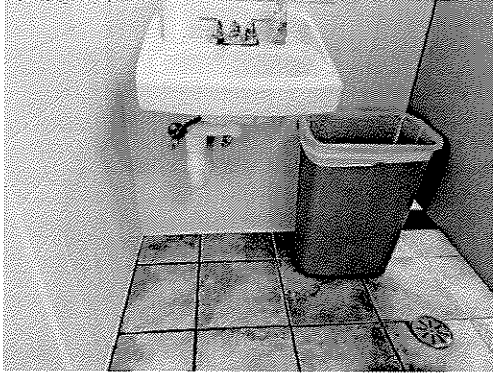
Bathroom sink with pipe cover
