All Appropriate Inquiry (AAI)
Phase I Environmental Site Assessment

Vacant Lots C3, C4 and T1
West of S. Cicero Avenue and east of Matteson Avenue
Matteson, IL 60443

Benchmark Project #18163
February 2, 2018

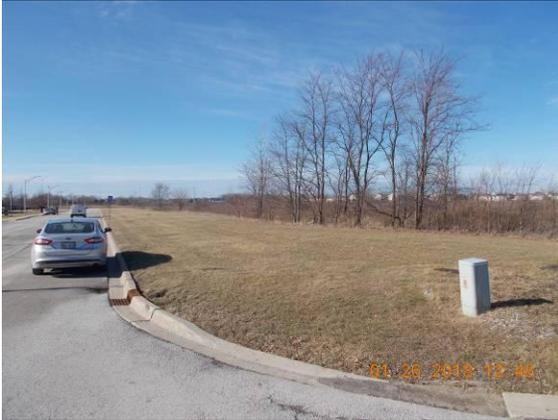
Subject site south property line facing west

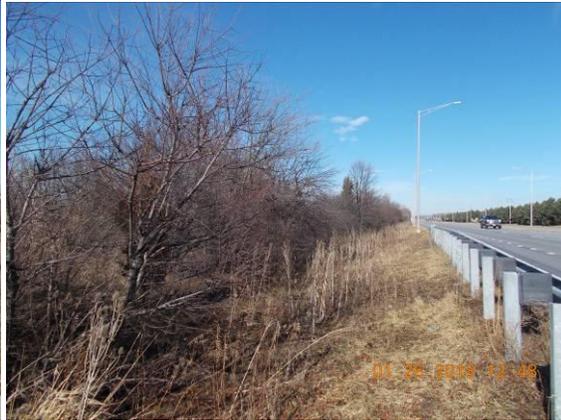
Subject site east property line facing north

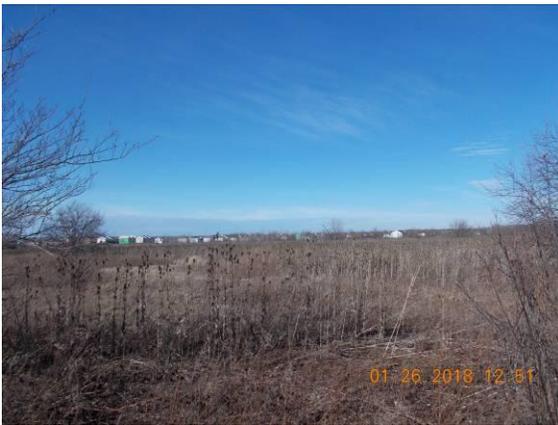
The subject site consists of eight (8) parcels of land totaling, approximately 30 acres in size currently vacant and, covered with low vegetation with shrubs/trees along the east and south property line. Several low-wet areas were observed. Deminimis amounts of solid waste/trash was observed on the subject site, along with one tire/wheel near the eastern property boundary.

Subject site-central facing west

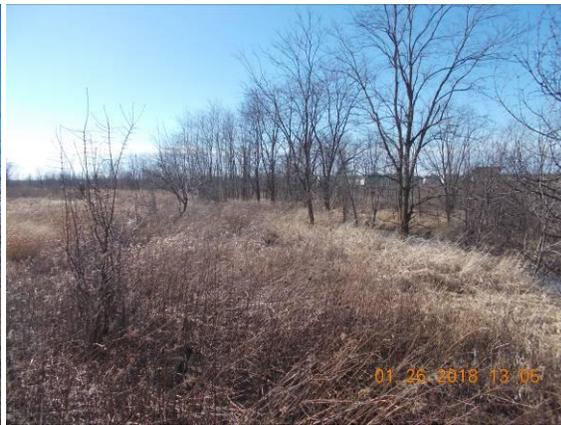
Subject site north property line facing southwest

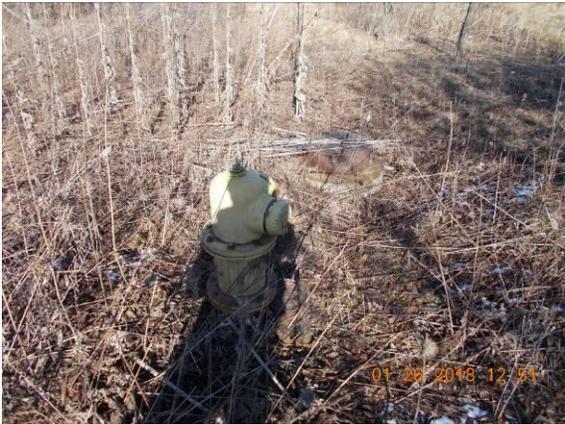
The subject site is currently vacant land and does not use water or produce any wastewater at this time. Benchmark observed fire hydrants and sewer manholes along the east and south sides of the subject site, which indicates that municipal water and sewage is available to the site. When developed, the subject site will be obtained water from the City of Chicago Water Department, and wastewater discharges will be received by the municipal sewer system, which is under the jurisdiction of the Metropolitan Wastewater Reclamation District of Greater Chicago (MWRD). Electric and natural-gas will be provided by the local utility companies.

Fire hydrant along the east property line

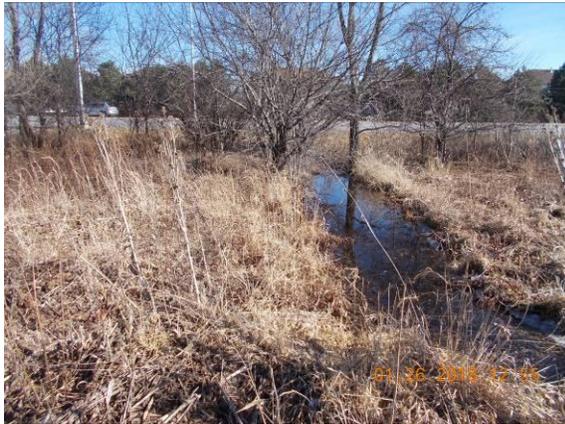
During Benchmark’s assessment of the property, potential wetland indicators were observed on the subject site. Before any development occurs, a wetland delineation is recommended for the subject site.

Potential wetland/drainage swale area along east

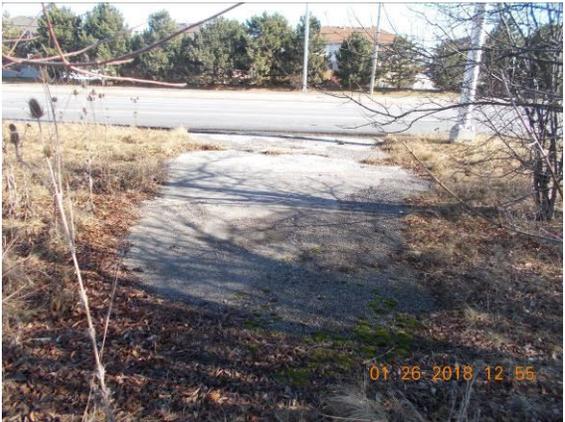
Small curb-cut along east off of Cicero Avenue

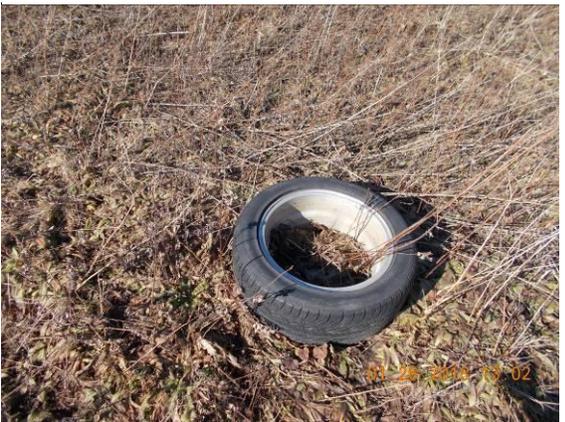
Benchmark only observed minor areas of solid waste which consisted of a tire/wheel and concrete debris.

Discarded tire near east side
