**PROJECT CAPITAL NEEDS ASSESSMENT
SECTION 232/223(f)
POLK CITY NURSING AND REHABILITATION
1002 WEST WASHINGTON AVENUE
POLK CITY, IOWA 50226
PROJECT NO. 103P067025**

Report Date: November 22, 2019
On-Site Date: November 12, 2019

Tetra Tech, Inc.
712 Melrose Avenue
Nashville, Tennessee 37211
Telephone (615) 252-4788

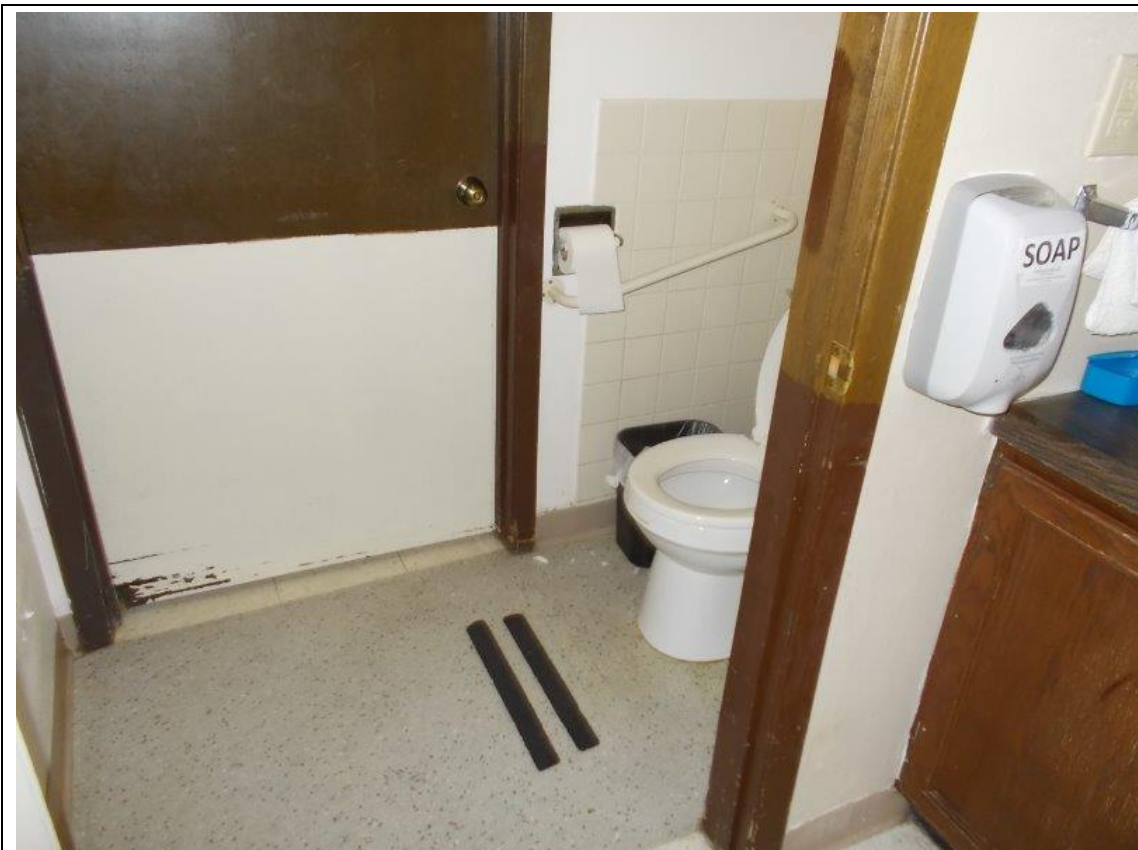
Photograph Number 44

Description:	View of a shared half bathroom between two double occupancy resident rooms.
---------------------	---

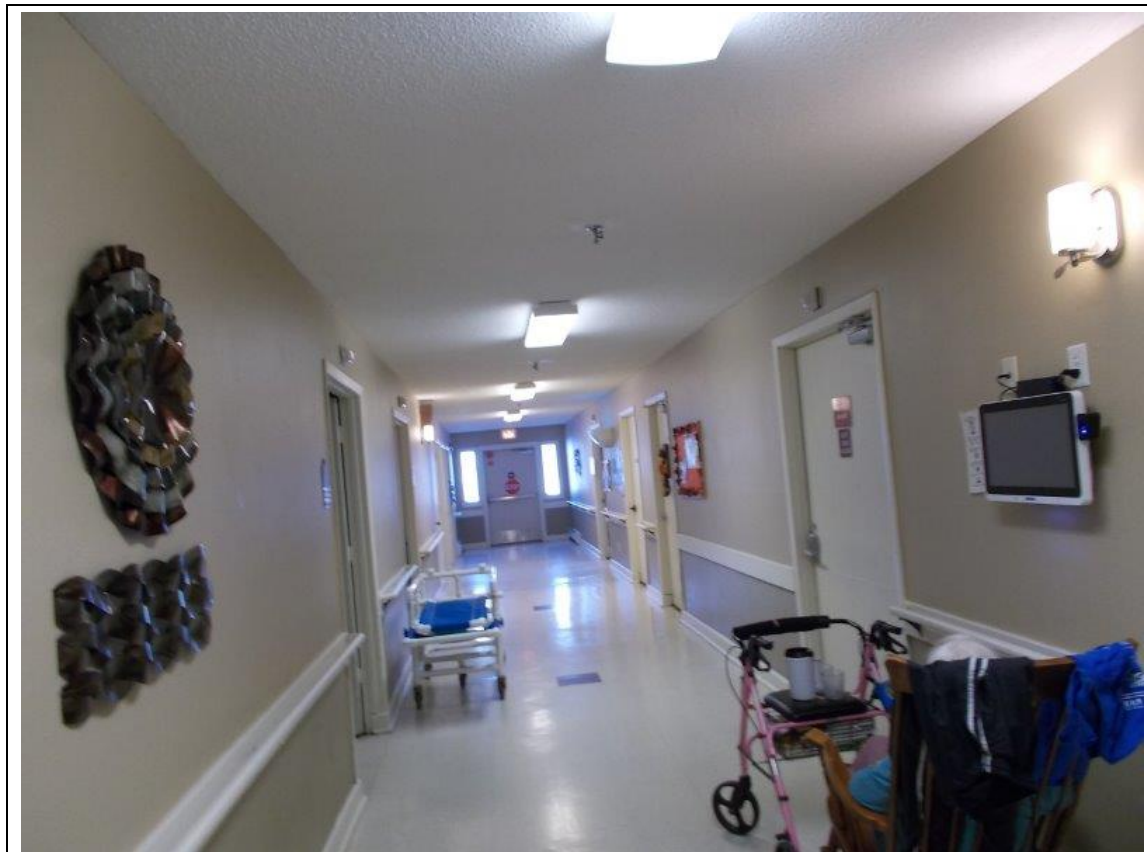
Photograph Number 45

Description:	View of a typical hallway.
---------------------	----------------------------

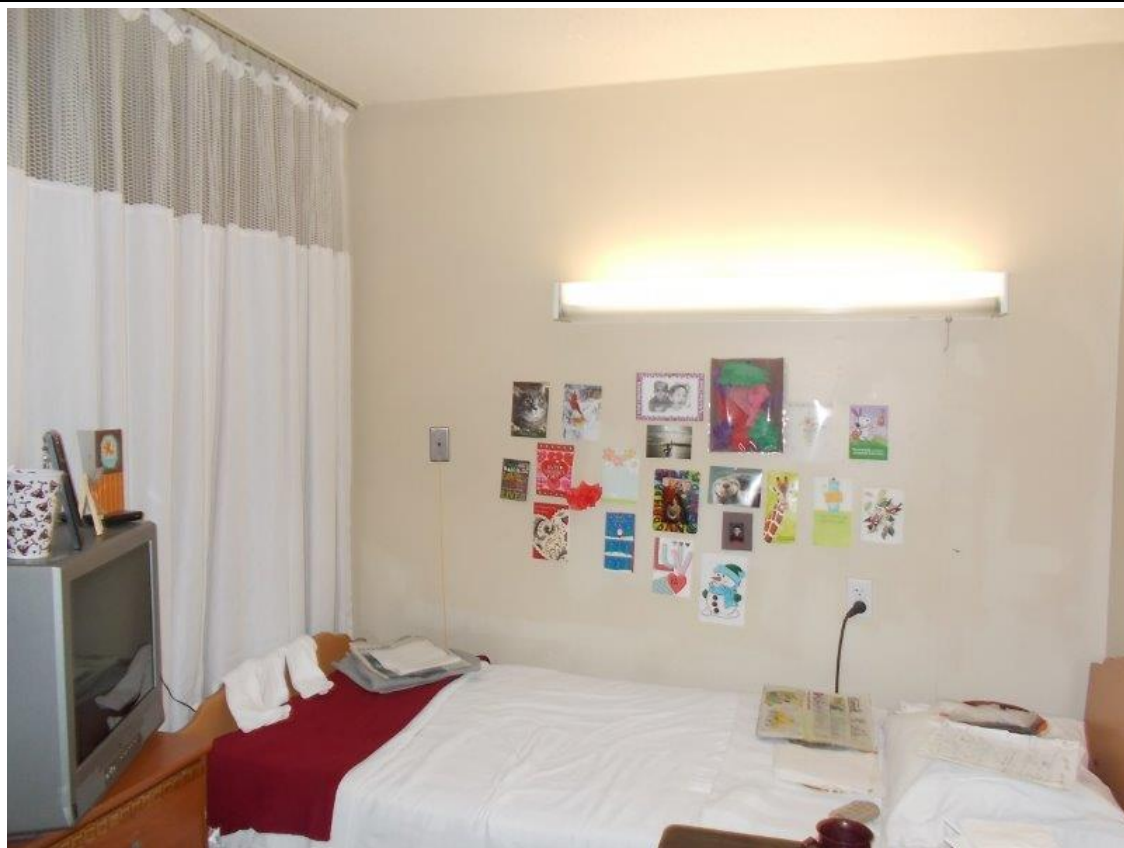
Photograph Number 46

Description:	View of a triple occupancy resident room.
---------------------	---

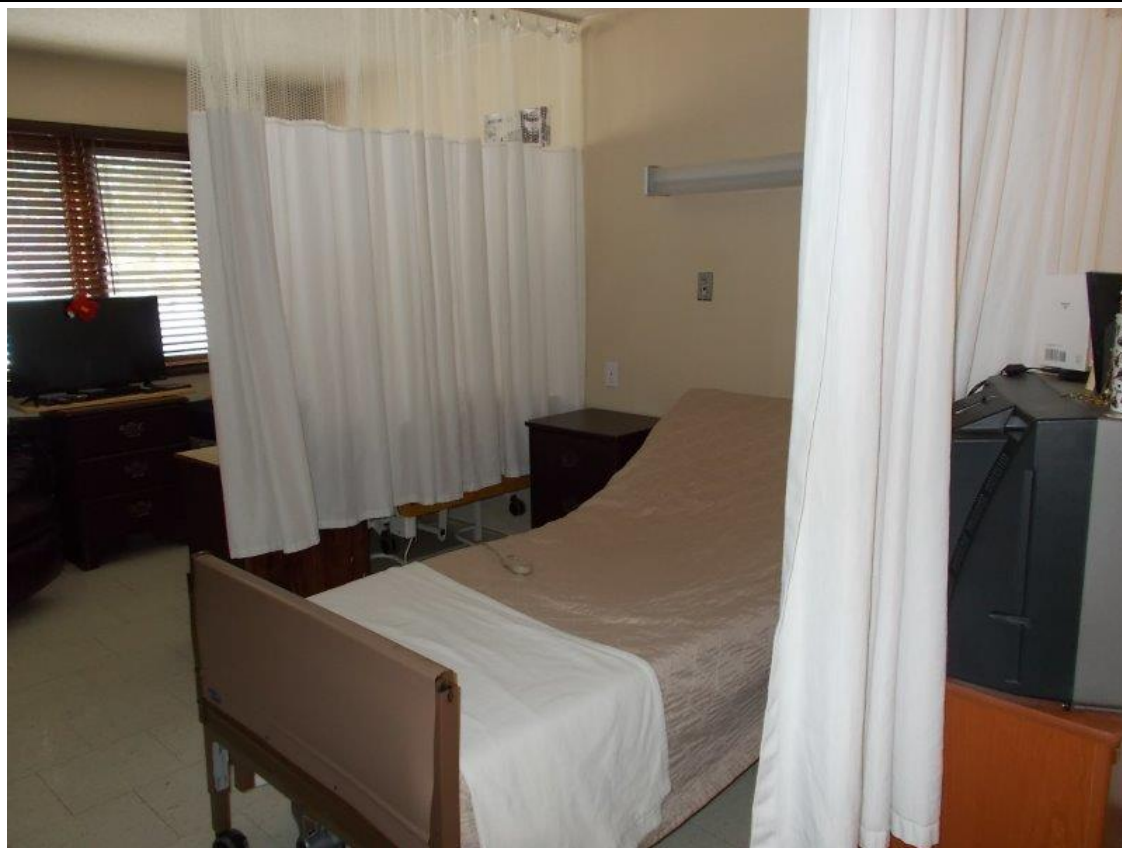
Photograph Number 47

Description:	View of a triple occupancy resident room.
---------------------	---

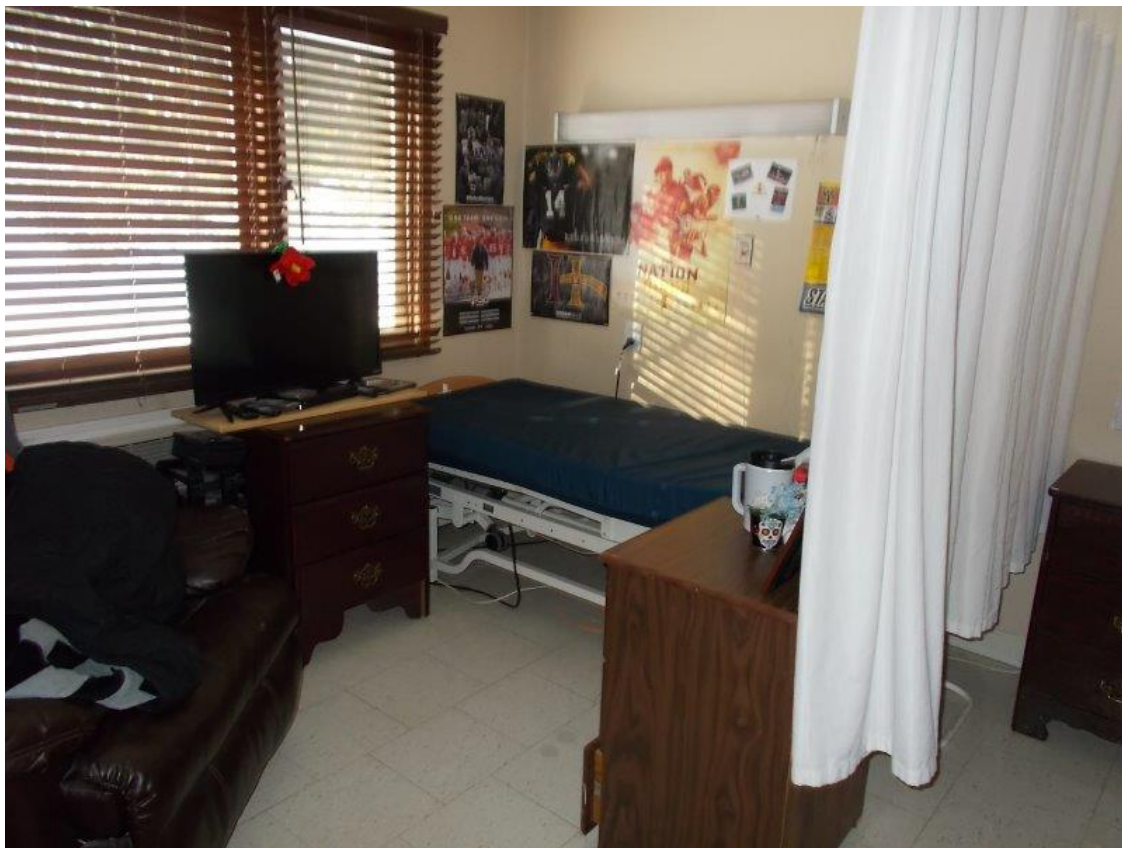
Photograph Number 48

Description:	View of a triple occupancy resident room.
---------------------	---

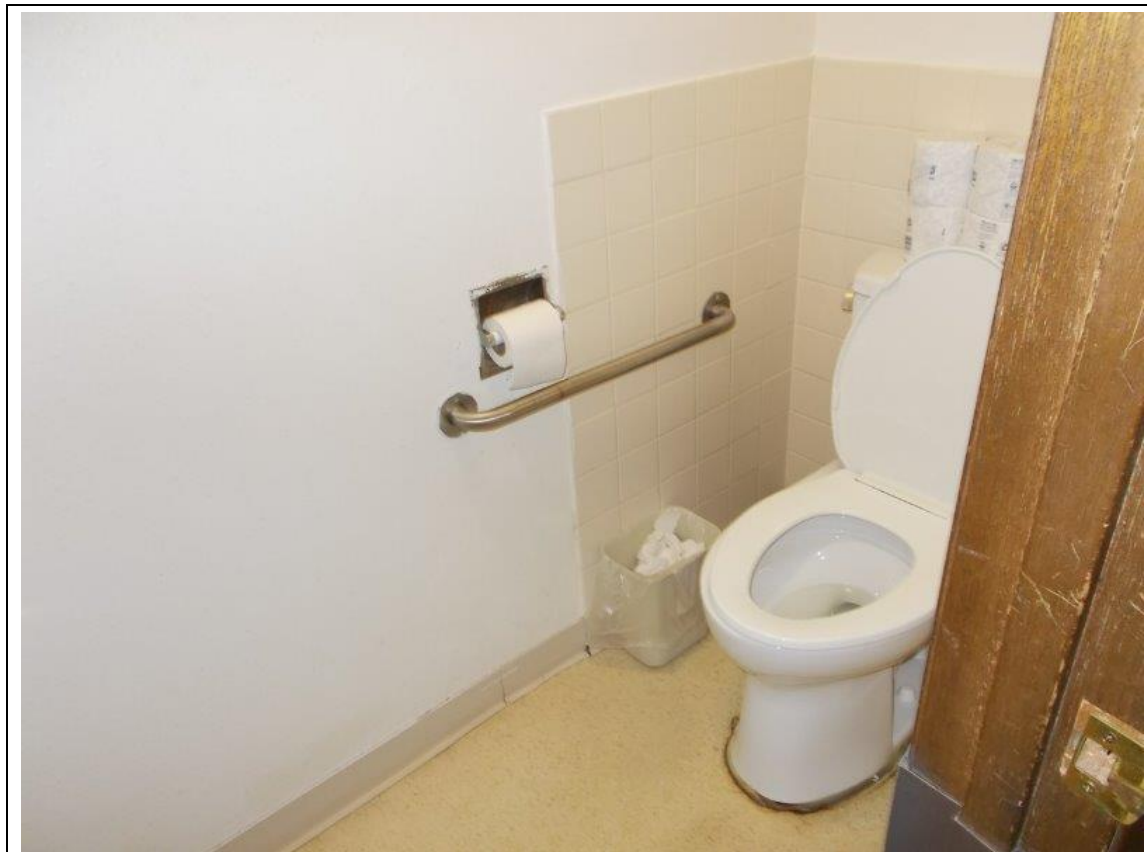
Photograph Number 50

Description:	View of the half bathroom in a triple occupancy resident room.
---------------------	--

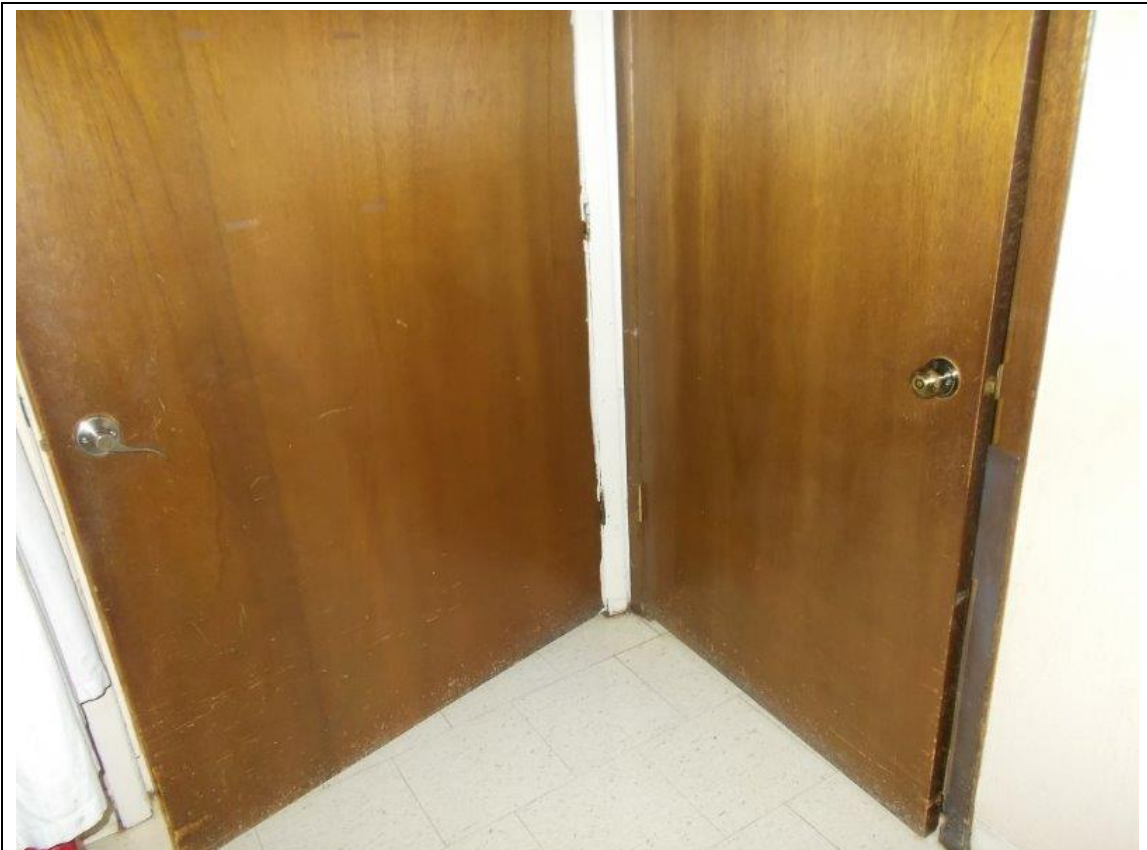
Photograph Number 51

Description:	View of door handles in a typical resident room. The corridor doors have lever action handles and the bathrooms have round handles.
---------------------	---

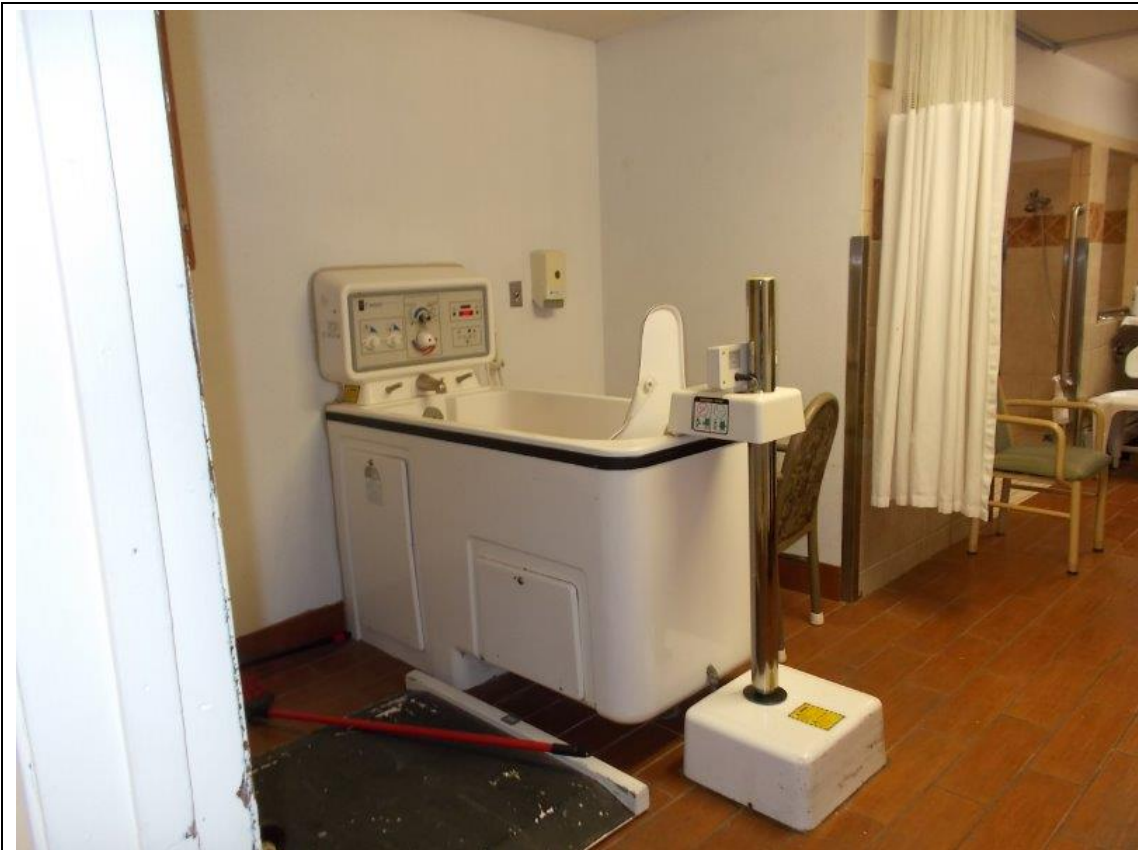
Photograph Number 52

Description:	View of a common spa/shower room.
---------------------	-----------------------------------

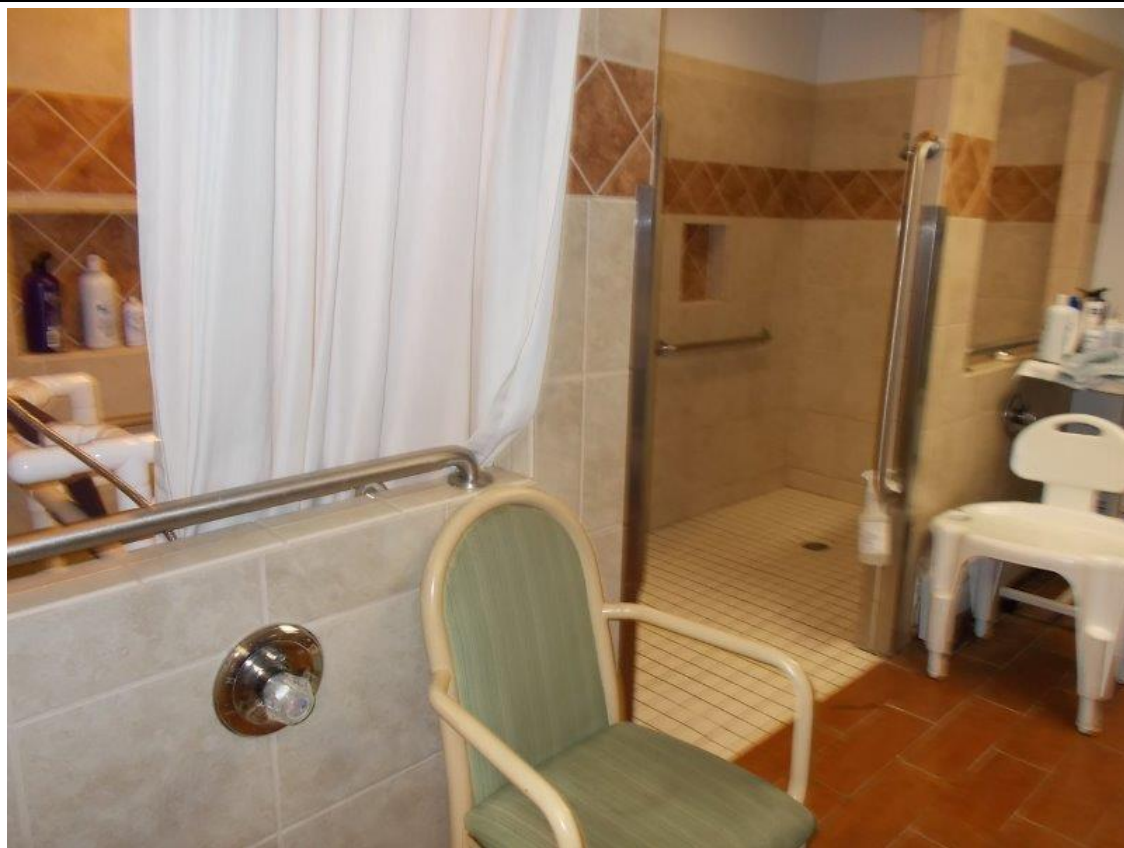
Photograph Number 53

Description:	View of a common spa/shower room.
---------------------	-----------------------------------

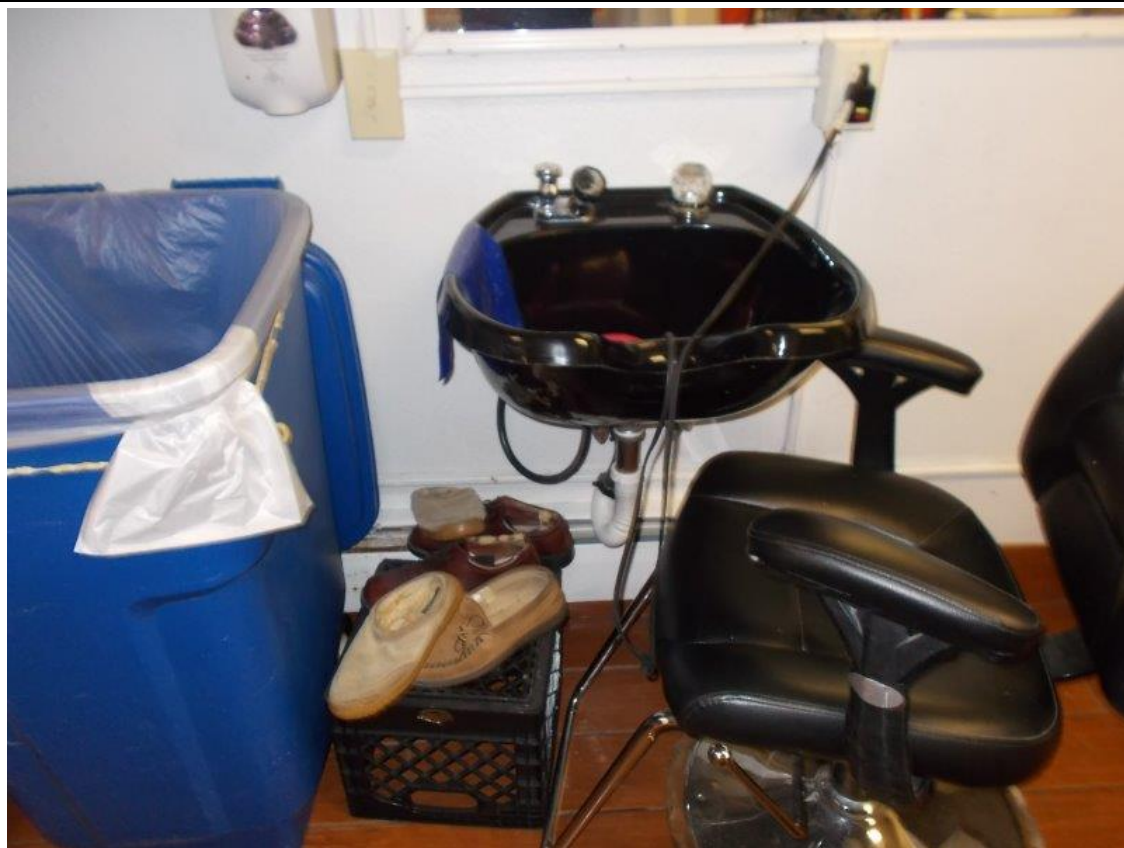
Photograph Number 54

Description:	View of the beauty salon, which shares the common spa/shower room.
---------------------	--

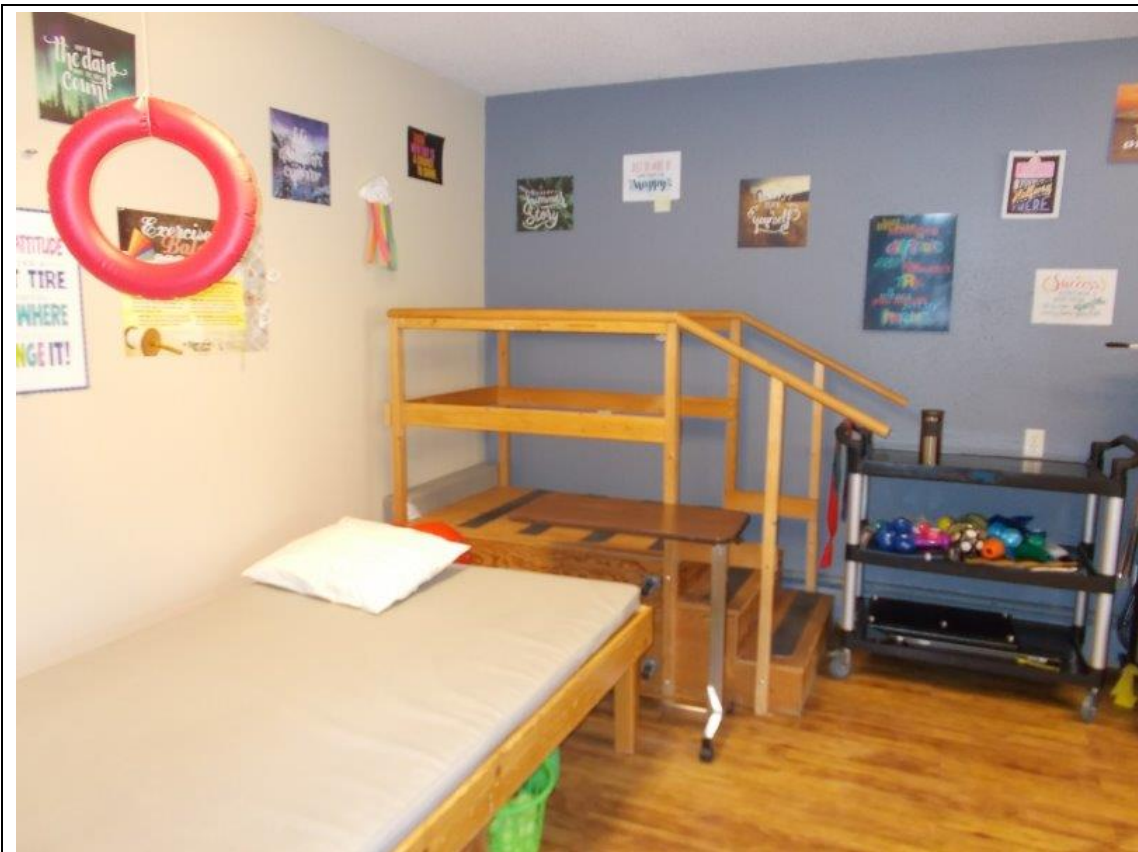
Photograph Number 55

Description:	View of the physical therapy room.
---------------------	------------------------------------

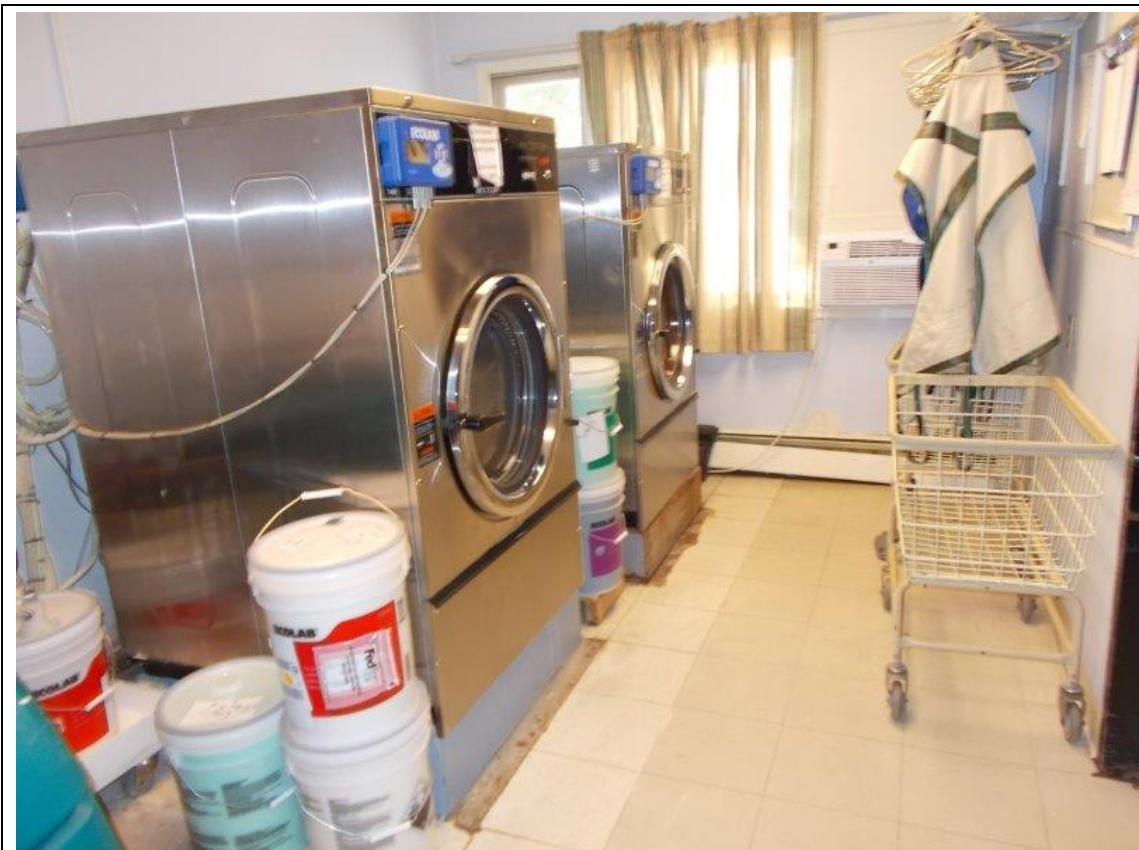
Photograph Number 56

Description:	View of two commercial capacity washers in the laundry room.
---------------------	--

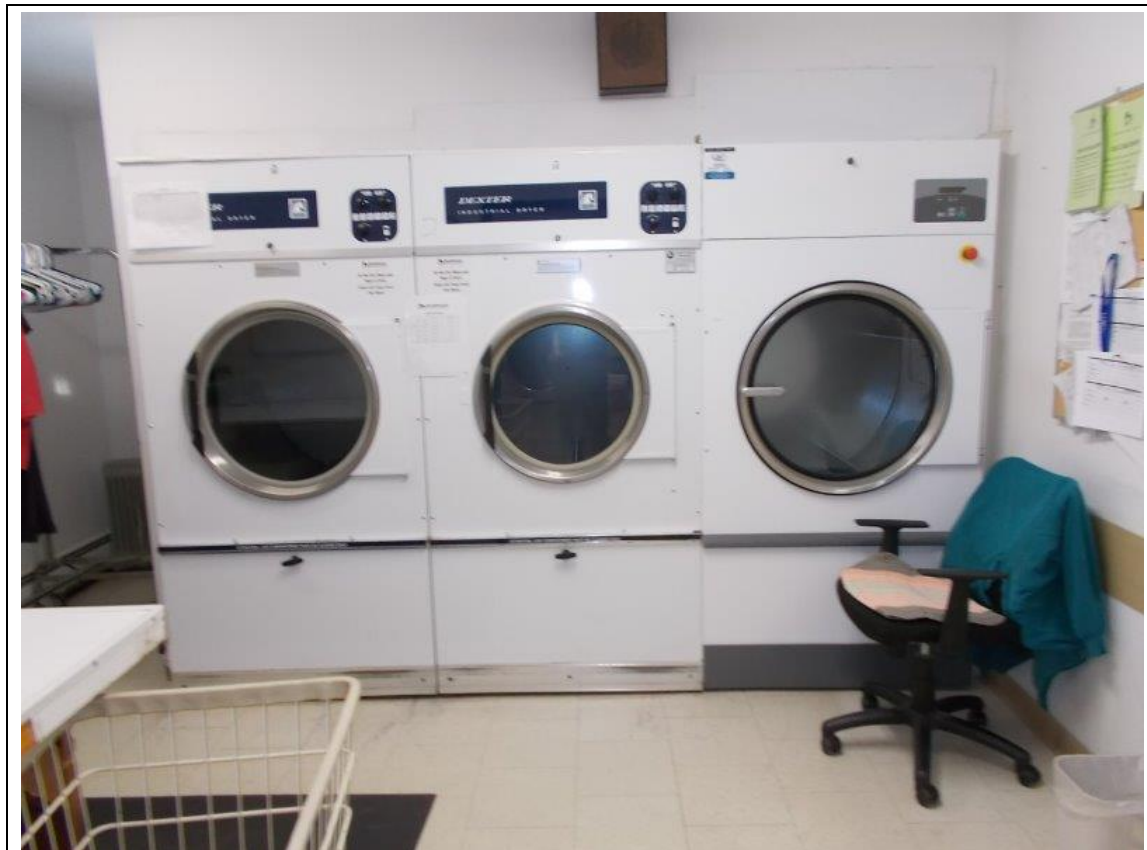
Photograph Number 57

Description:	View of three natural gas fired commercial dryers in the laundry room.
---------------------	--

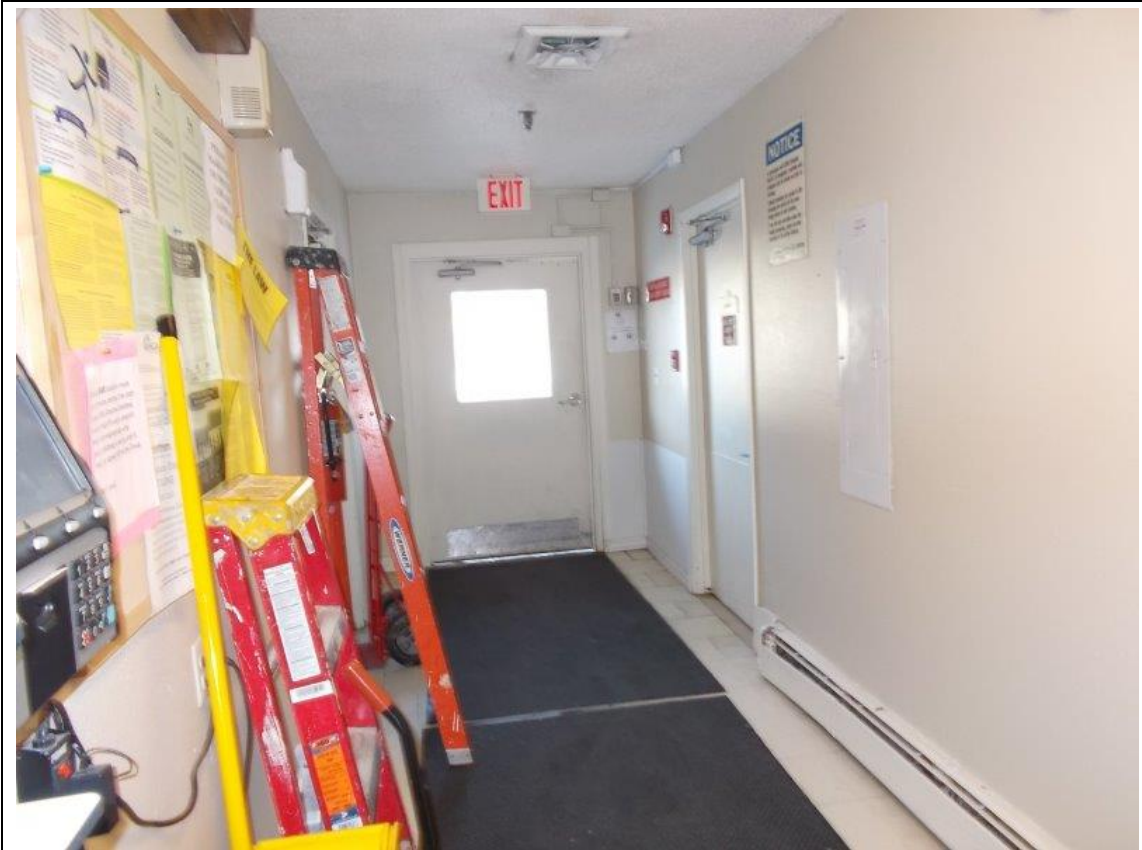
Photograph Number 58

Description:	View of the service hallway.
---------------------	------------------------------

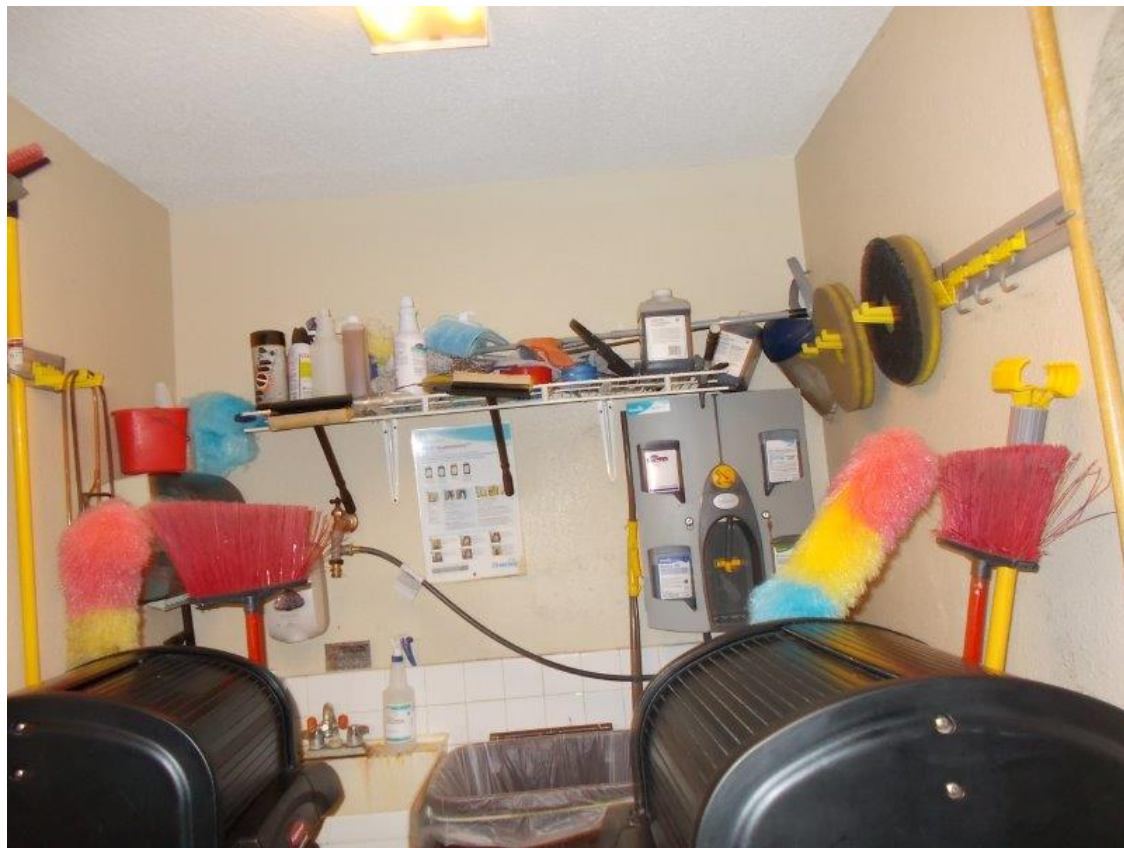
Photograph Number 59

Description:	View of a janitorial/housekeeping room.
---------------------	---

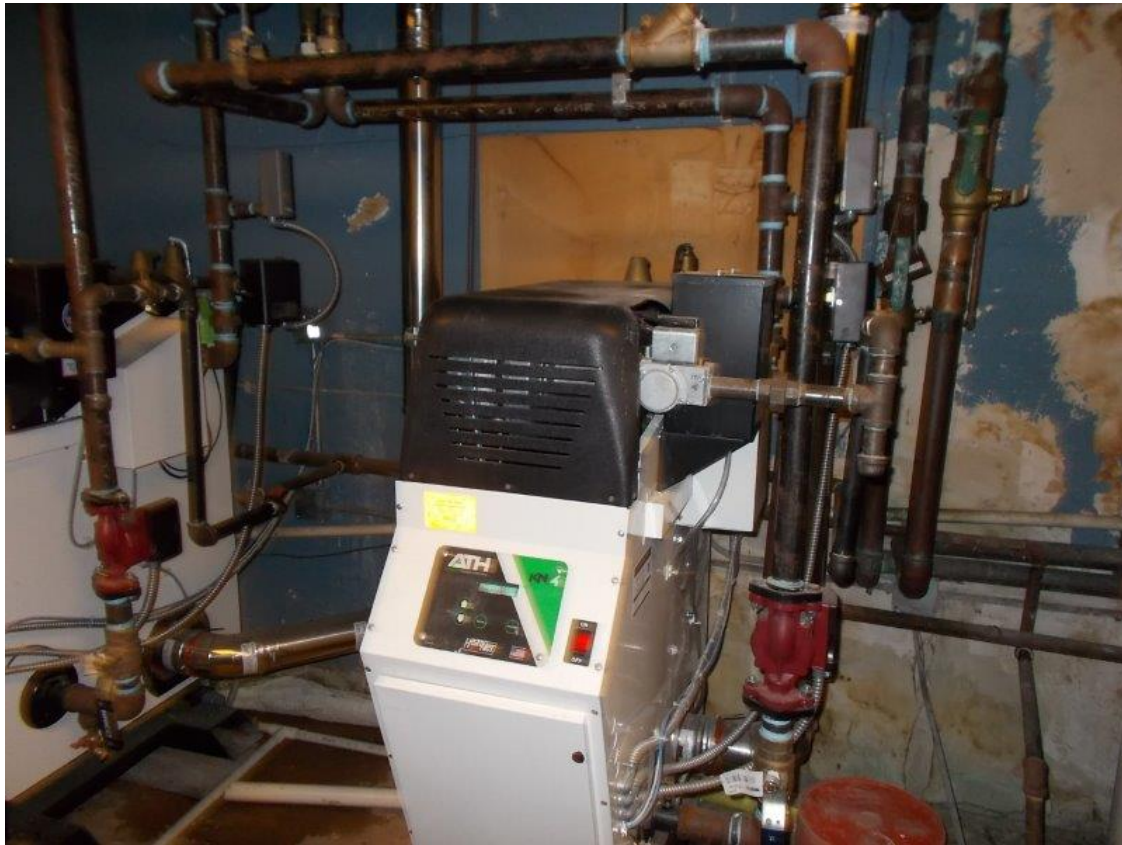
Photograph Number 61

Description:	View of a natural gas-fired 400,000 British Thermal Unit (BTU) per hour boiler for the hydronic heating system, located in the boiler room.
---------------------	---

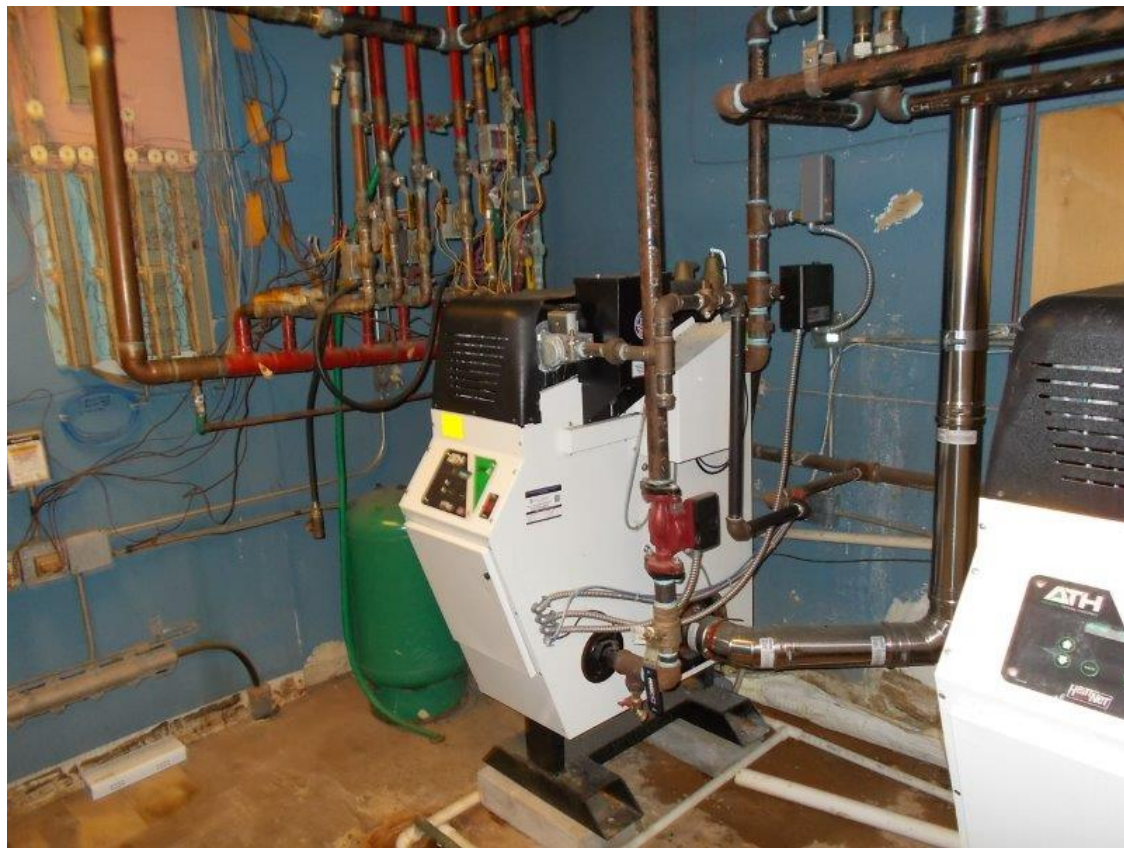
Photograph Number 62

Description:	View of a second boiler for the hydronic heating system, also in the boiler room.
---------------------	---

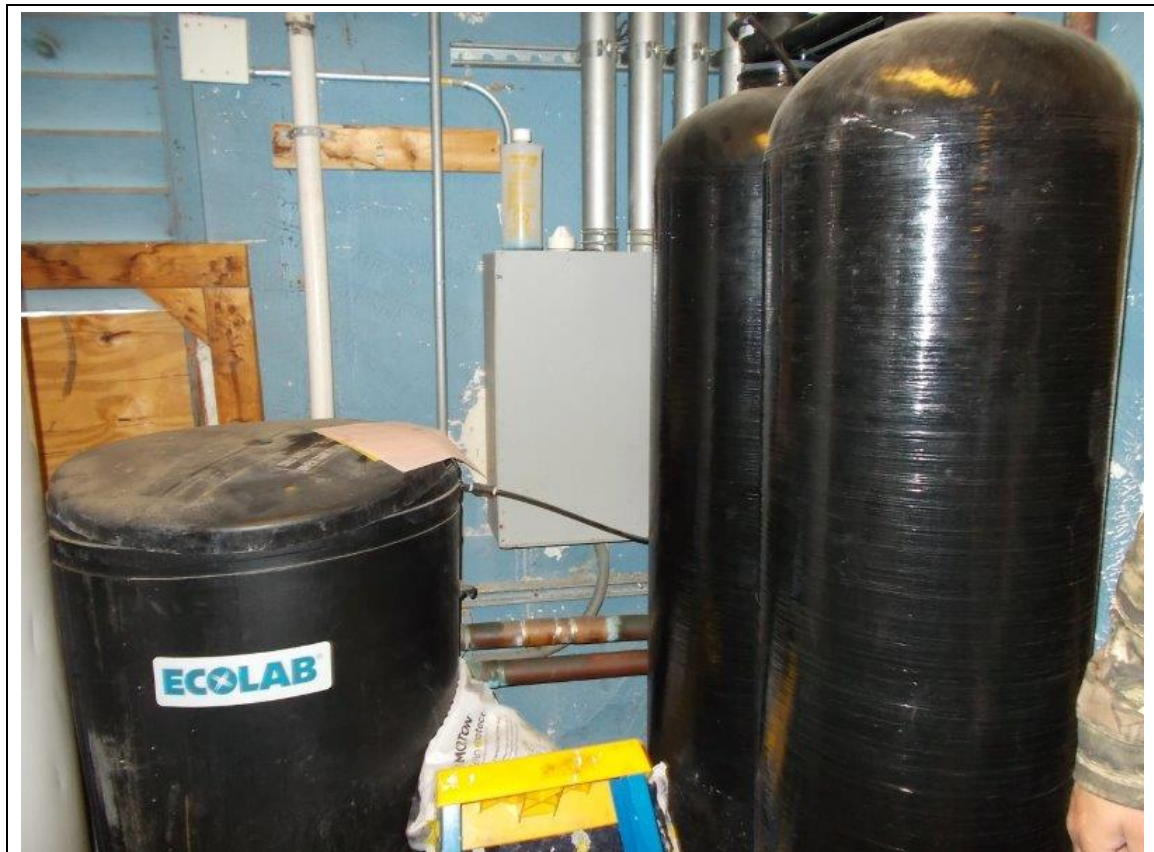
Photograph Number 63

Description:	View of the water softener system in the boiler room.
---------------------	---

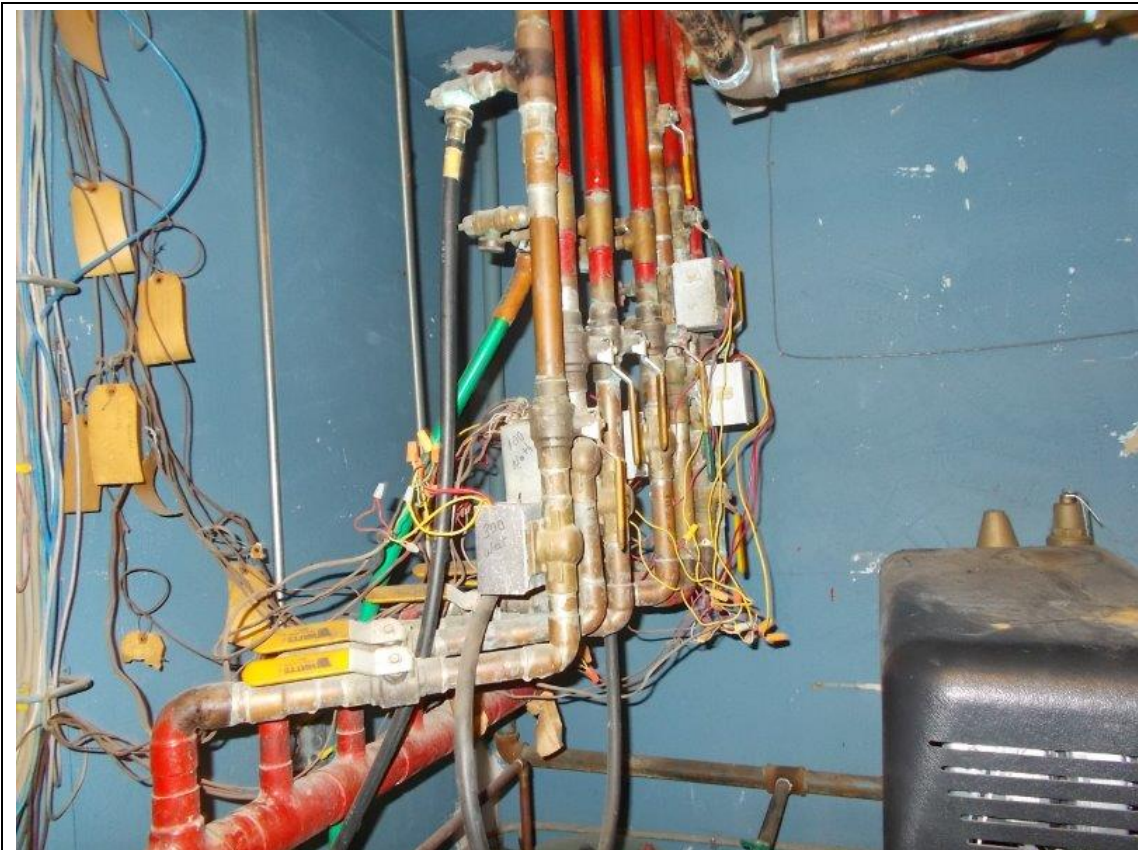
Photograph Number 64

Description:	View of piping in the boiler room.
---------------------	------------------------------------

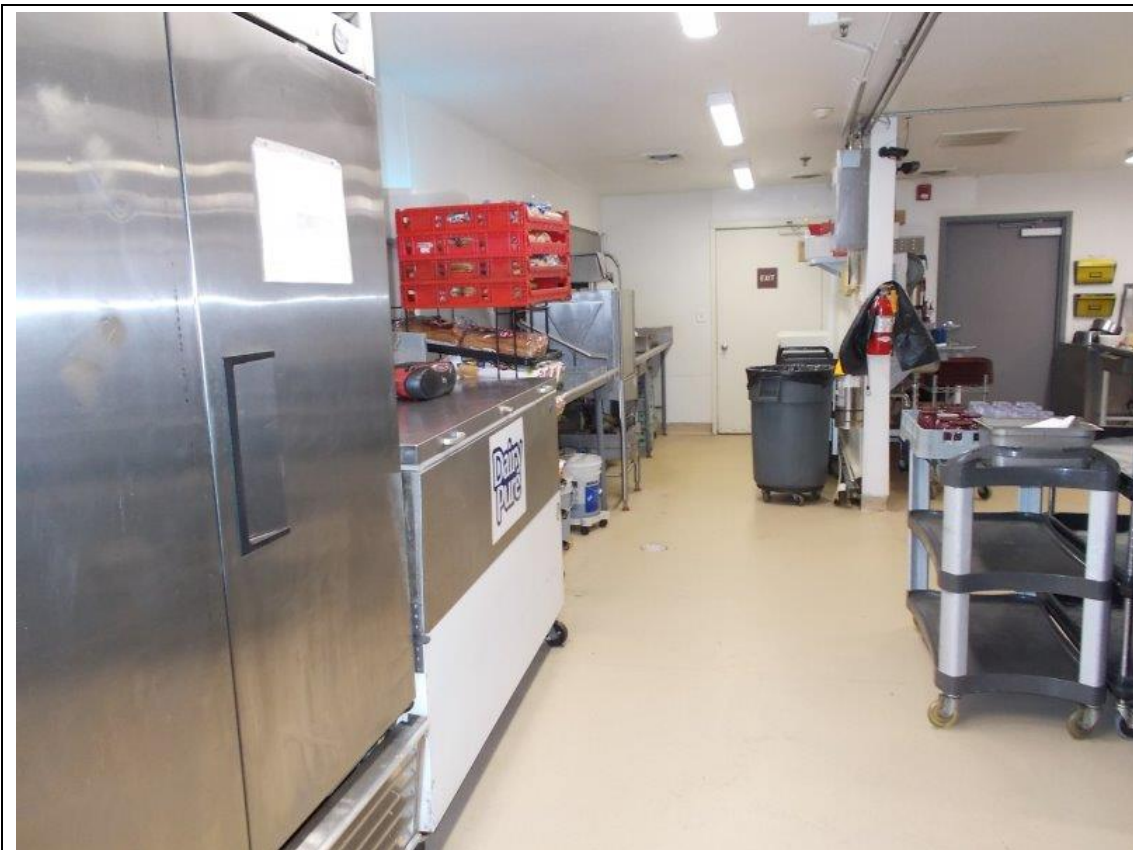
Photograph Number 65

Description:	View of the kitchen finishes.
---------------------	-------------------------------

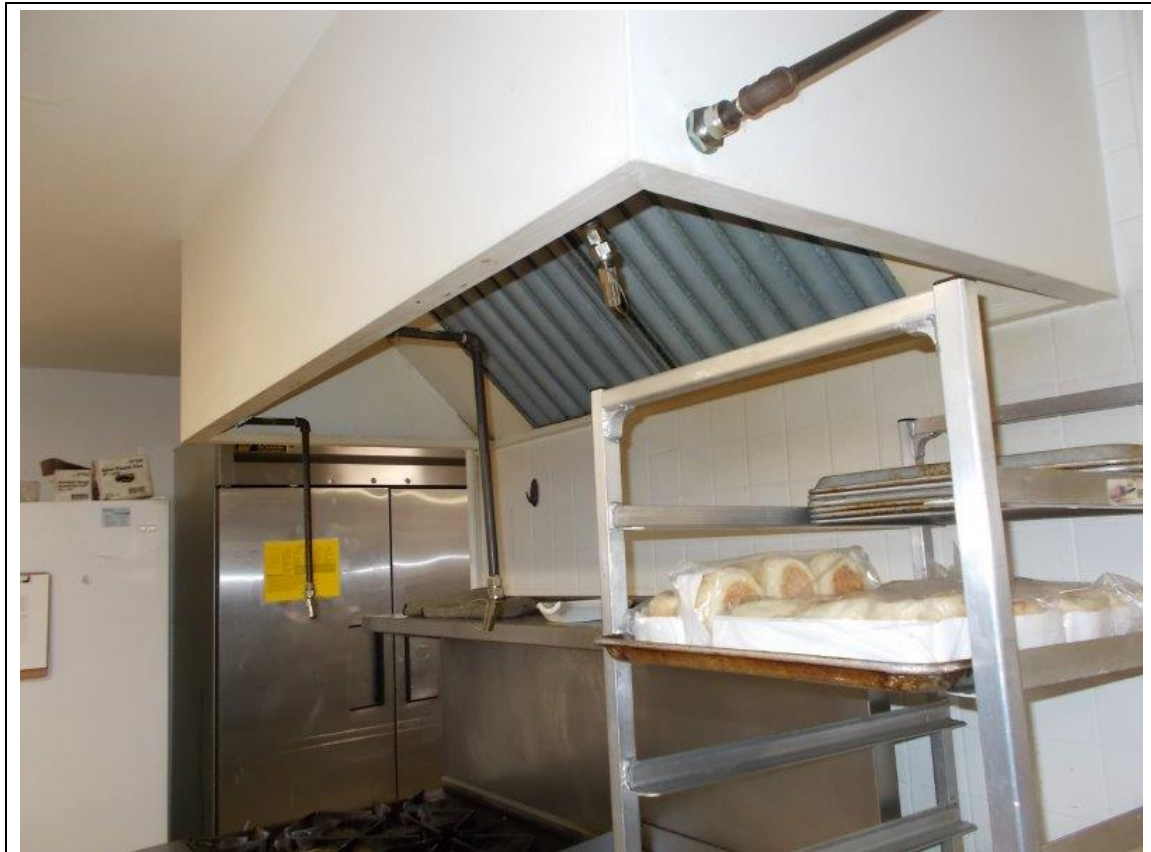
Photograph Number 66

Description:	View of the vent hood and fire suppression system in the kitchen.
---------------------	---

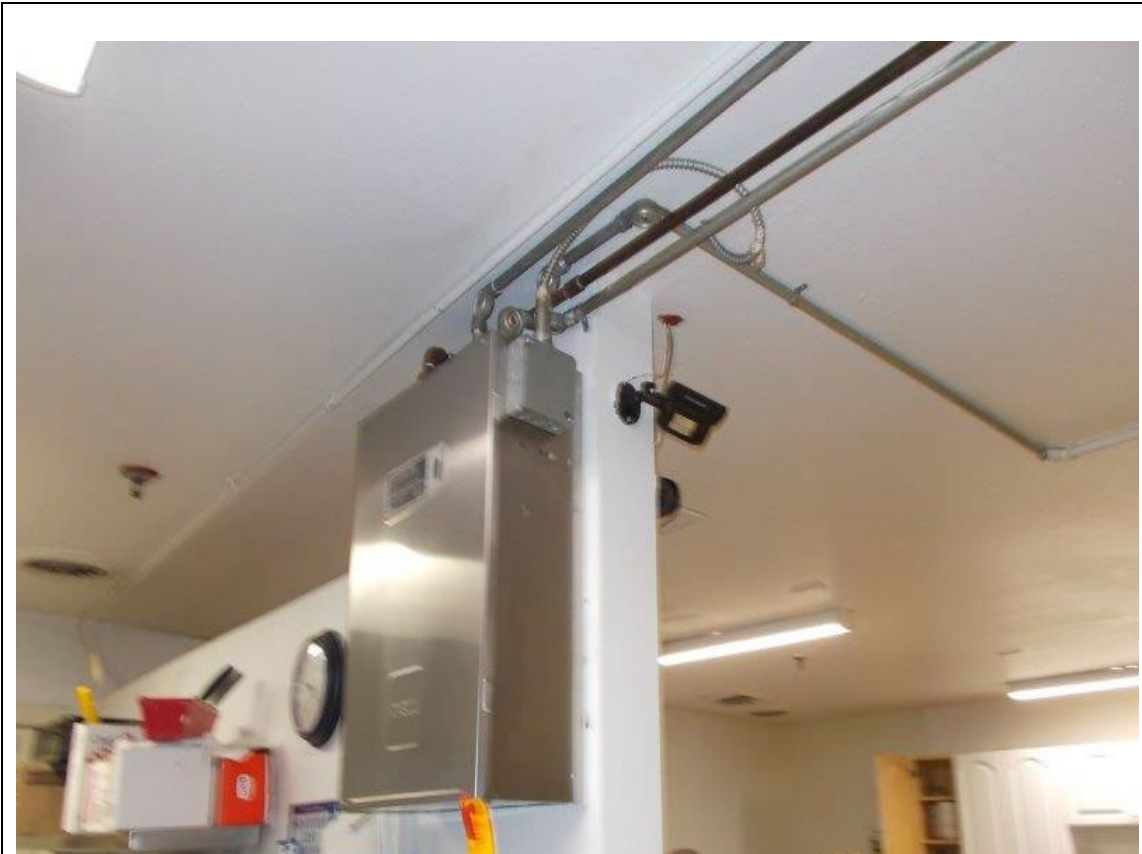
Photograph Number 67

Description:	View of the ANSUL fire suppression supply reservoir in the kitchen.
---------------------	---

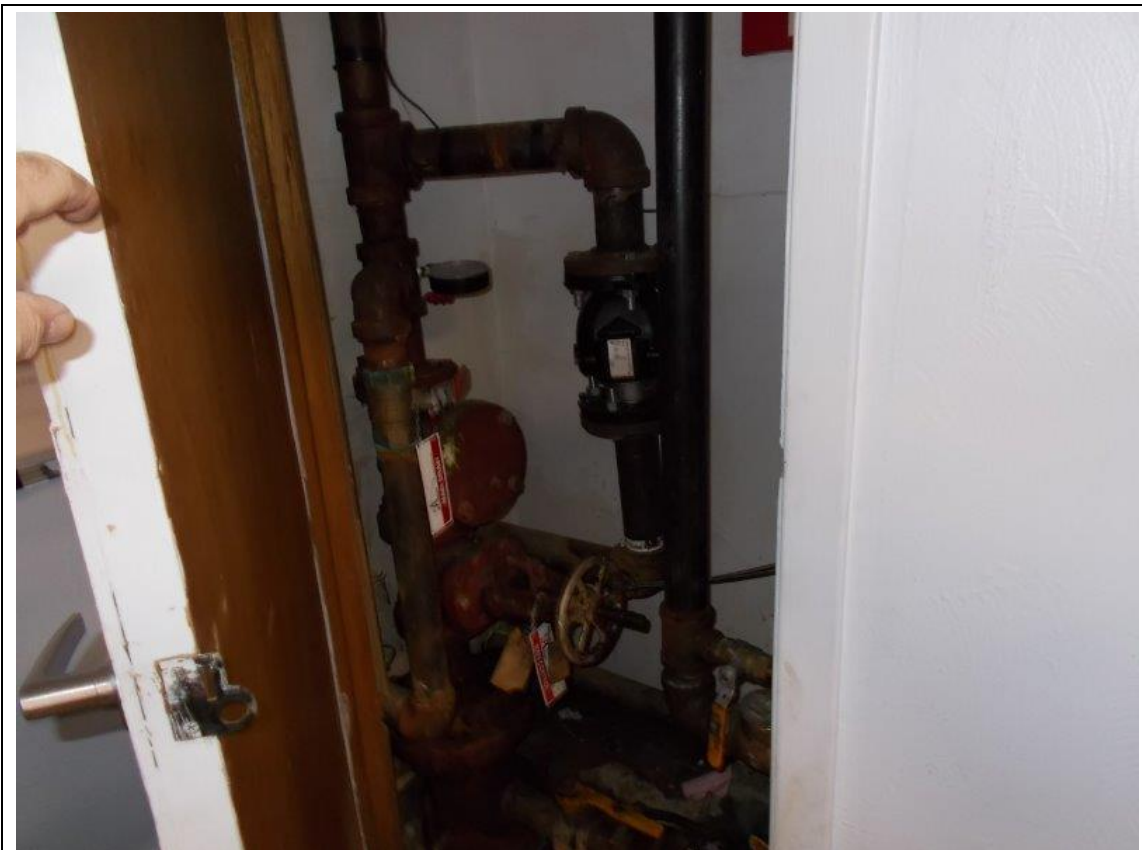
Photograph Number 68

Description:	View of the fire riser for the sprinkler system.
---------------------	--
